Ref: 1W01

Location:
Police Station, First floor

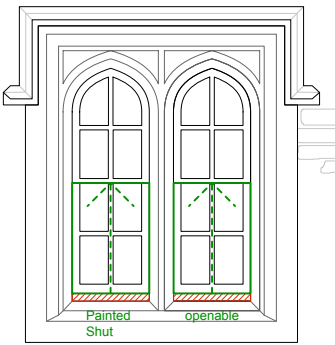
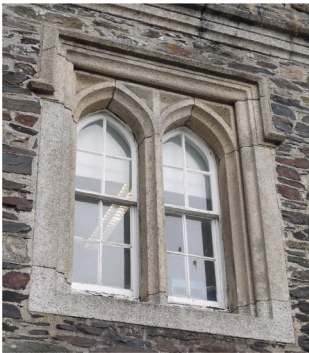
Type Existing:
Timber framed double hung single glazed sash windows

Repair Code:
Code: 3

Comments:
- **Option A:** No Draught Seals
- **Option B:** Draught Seal - weatherstrip around perimeter of sashes / recessed brush seal to sash meeting rail.

Proposed Works:
Rotten cill to be replaced in new hardwood, Rake out dead and defective putties and replace in linseed oil putty, cut out swollen joints and repair using window care repair if required. Sash cords, weights, staff beads & parting beads to be refurbished where required. Window and subframe to be prepared, with painted finish.

Subframe/ surround:
To all granite mullions and window surrounds, strip back all paintwork

Ironmongery:
to be refurbished and/ or replaced where required.

Finish:
Paint windows with 2no. undercoats and finish with 1no. gloss finishing coat

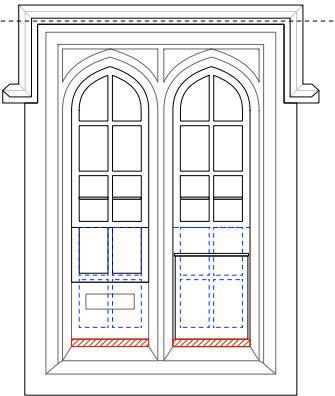
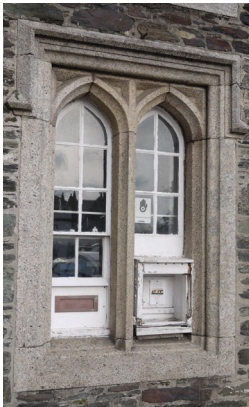
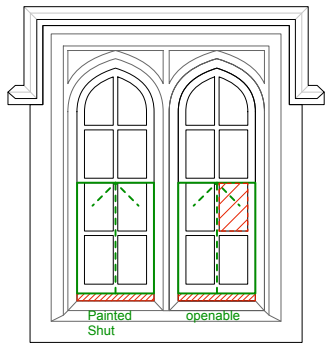
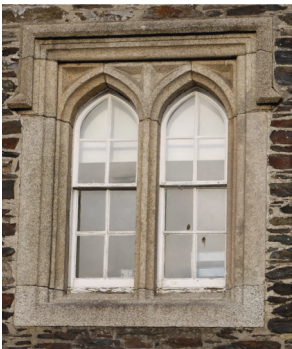
Ref: 1W02

Type Existing:
Timber framed double hung single glazed sash windows

Repair Code:
Code: 3

Proposed Works:
Rotten cill to be replaced in new hardwood, Rake out dead and defective putties and replace in linseed oil putty, cut out swollen joints and repair using window care repair if required. Sash cords, weights, staff beads & parting beads to be refurbished where required. Replace existing damaged glass with new clear float glass to match existing windows. Window and subframe to be prepared, with painted finish.

Glazing:
* Single clear float glass to match existing windows

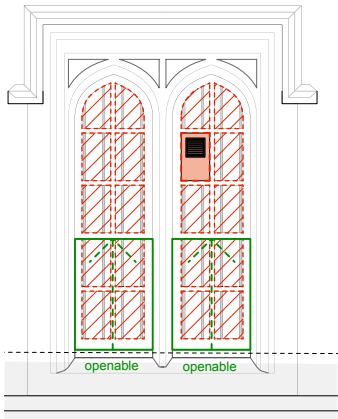
Ref: 2W01

Type Existing:
Timber framed single glazed side hung windows

Repair Code:
Code: 3

Ironmongery:
Ironmongery appears to be in acceptable condition on inspection

Proposed Works:
Rotten cill to be replaced in new hardwood, Rake out dead and defective putties and replace in linseed oil putty, cut out swollen joints and repair using window care repair if required. Burn off all defective paintwork. Window and subframe to be prepared, with painted finish.

Subframe/ surround:
To all granite mullions and window surrounds, strip back all paintwork.

New replacement lead cill flashing to extend to full depth of cill.

Finish:
Paint windows with 2no. undercoats and finish with 1no. Gloss finishing coat

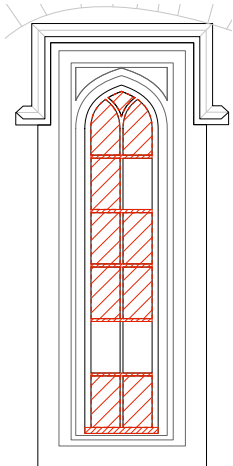
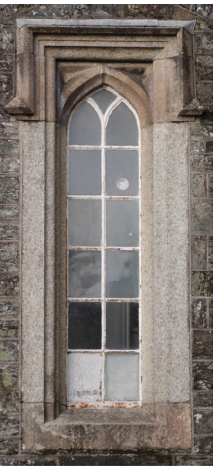
Ref: 1W03

Type Existing:
Single glazed fixed metal framed period crittall window.

Code: 2

Comments:
Heavy corrosion apparent on mullions and at cill level.

Proposed Works:
Burn off paintwork and wire brush steel work. Treat corroded areas with zinc rich paint, replace defective putties. Existing opaque and textured glass to be removed and replaced with new clear float glass. .Window and subframe to be prepared, with painted finish.

Subframe/ surround:
To all granite mullions and window surrounds, strip back all paintwork.

New replacement lead cill flashing to extend to full depth of cill.

Ironmongery:
to be refurbished and/ or replaced where required.

Finish:
Paint windows with 2no. coats.
