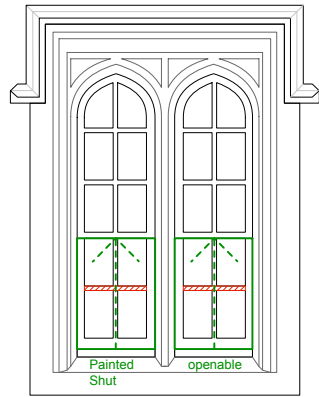
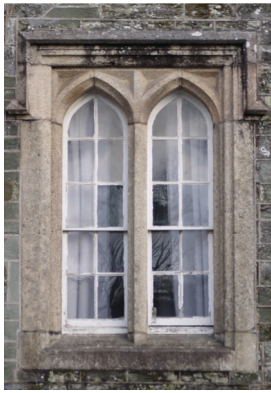
Ref: 2W02

Type Existing:
Timber framed side hung single glazed windows

Comments:
Rehang unit so that it opens with restrictor to 100mm maximum.

Proposed Works:
Rotten cill to be replaced in new hardwood with new internal timber cill. Cut out and replace cill, burn off all paint and remove defective putties, replace putty in new linseed oil. Replace existing damaged glass with new clear float glass to match existing windows. Window and subframe to be prepared, with painted finish.

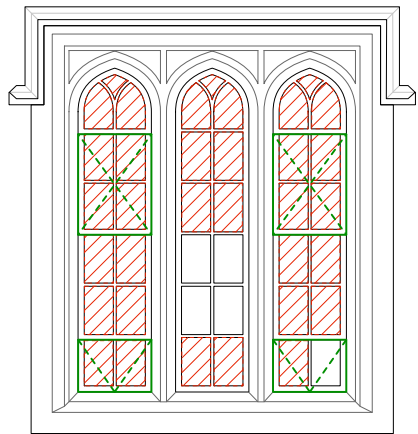
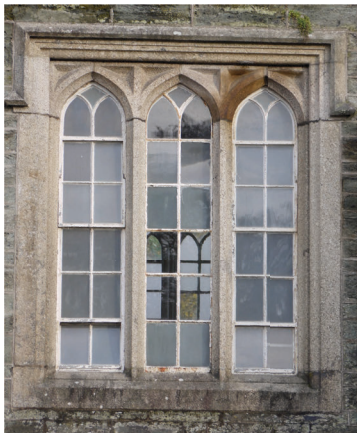
Ref: 1W04

Comments:
Rot apparent on mullions

Proposed Works:
Burn off defective and peeling paint rake out and replace defective putties, repair defective timber. Cut out swollen joints and repair using window care repair on rotten mullions. Sash cords, weights, staff beads & parting beads to be refurbished where required. Window and subframe to be prepared, with painted finish.

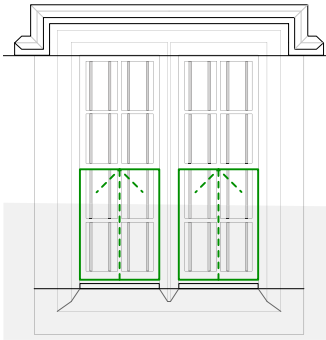
Ref: 1W05

Comments:
- There is significant paint peel to the internal plaster window reveals
- **Black Out Roller Blind required to fit within existing slot in window reveal**

Proposed Works:
Rake out all defective putties and replace in linseed oil putty, burn off all paintwork and spot prime corroded areas using zinc rich paint. Existing opaque and textured glass to be removed and replaced with new clear float glass. Window and subframe to be prepared, with painted finish.

Subframe/ surround:
To all granite mullions and window surrounds, strip back all paintwork. Plaster window reveals to be stripped of paint and repainted with breathable paint.

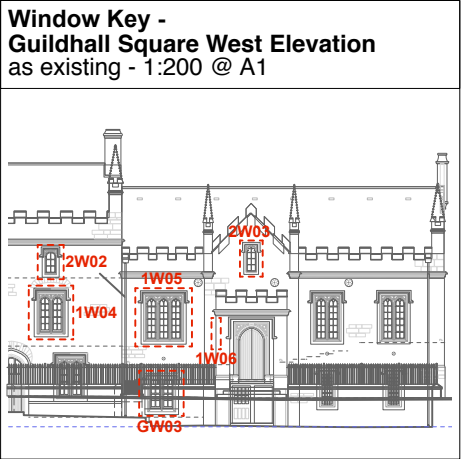
Ref: 1W06

Type Existing:
Single glazed metal framed period crittall window.

Comments:
Fixed

Proposed Works:
Burn off all paintwork. Prepare and spot prime areas of corrosion to steelwork, replace defective putties. Existing opaque and textured glass to be removed and replaced with new clear float glass. Window and subframe to be prepared, with painted finish.
