**Window Key -
Guildhall Square East Elevation
as existing - 1:200 @ A1**

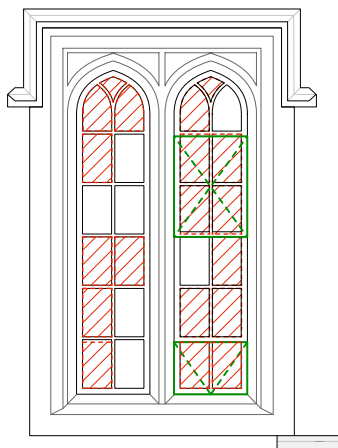
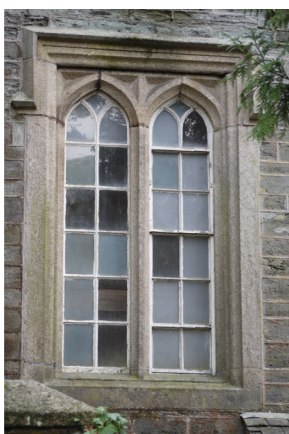
Ref: **1W11**

Type Existing:
Double window, Single glazed metal framed
crittall window.

Comments:
- Corrosion apparent throughout, There is significant paint peel to the plaster window reveals.
- **Black Out Roller Blind required to fit within existing slot in window reveal**

Proposed Works:
Rake out all defective putties and replace in
linseed oil putty, burn off all paintwork and
spot prime corroded areas using zinc rich
paint. Thoroughly clean down all paintwork to
windows, overhaul and replace and re-grease
all working mechanisms. Existing opaque and
textured glass to be removed and replaced
with new clear float glass. Window and
subframe to be prepared, with painted finish.

Subframe/ surround:
To all granite Mullions and window surrounds, strip back all paintwork. Plaster window reveals to be stripped of paint and repainted with breathable paint.

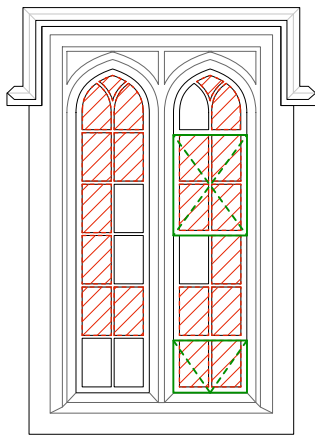
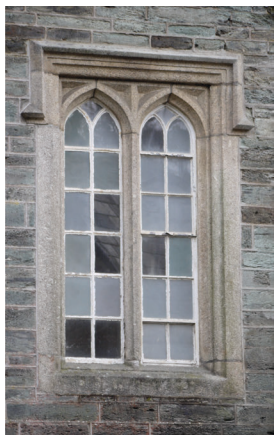
Ref: **1W14**

Type Existing:
Double window, Single glazed metal framed period crittall window.

Comments:
- Corrosion apparent throughout
- **Black Out Roller Blind required to fit within existing slot in window reveal**

Proposed Works:
Rake out all defective putties and replace in linseed oil putty, burn off all paintwork and spot prime corroded areas using zinc rich paint. Thoroughly clean down all paintwork to windows, overhaul and replace and re-grease all working mechanisms. Existing damaged, opaque and textured glass to be removed and replaced with new clear float glass. Window and subframe to be prepared, with painted finish.

Subframe/ surround:
To all granite Mullions and window surrounds, strip back all paintwork. Plaster window reveals to be stripped of paint and repainted with breathable paint.

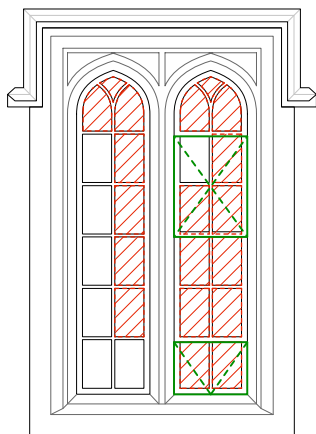
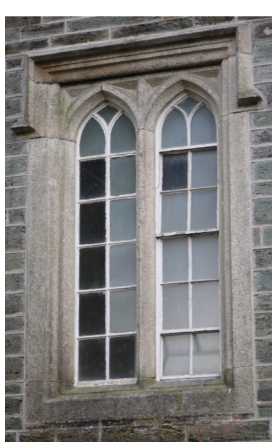
Ref: **1W12**

Type Existing:
Double window, Single glazed metal framed crittall window.

Comments:
- Corrosion apparent throughout
- **Black Out Roller Blind required to fit within existing slot in window reveal**

Proposed Works:
Rake out all defective putties and replace in linseed oil putty, burn off all paintwork and spot prime corroded areas using zinc rich paint. Thoroughly clean down all paintwork to windows, overhaul and replace and re-grease all working mechanisms. Existing damaged, opaque and textured glass to be removed and replaced with new clear float glass. Window and subframe to be prepared, with painted finish.

Subframe/surround:
To all granite mullions and window surrounds, strip back all paintwork. Plaster window reveals to be stripped of paint and repainted with breathable paint.

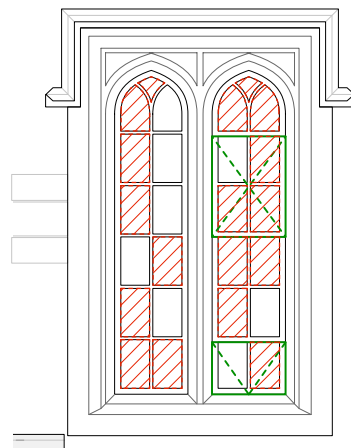
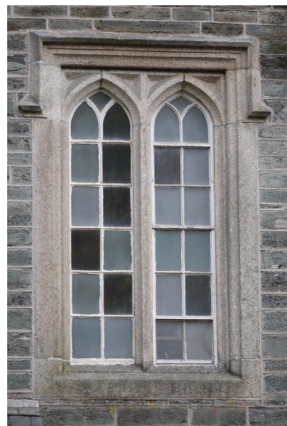
Ref: **1W13**

Type Existing:
Double window, Single glazed metal framed crittal window.

Comments:
- Corrosion apparent throughout
- **Black Out Roller Blind required to fit within existing slot in window reveal**

Proposed Works:
Rake out all defective putties and replace in linseed oil putty, burn off all paintwork and spot prime corroded areas using zinc rich paint. Thoroughly clean down all paintwork to windows, overhaul and replace and re-grease all working mechanisms. Existing damaged, opaque and textured glass to be removed and replaced with new clear float glass. Window and subframe to be prepared, with painted finish.

Subframe/ surround:
To all granite mullions and window surrounds, strip back all paintwork. Plaster window reveals to be stripped of paint and repainted with breathable paint.
