## **Tavistock Guild Hall Drainage Report Summary – Glanville Environmental – 19.09.12**

Project name :  
**Tavistock Guild Hall - 18-09-2012**

Client: **Devon Historic Buildings Trust**

Site: **Tavistock Guild Hall**

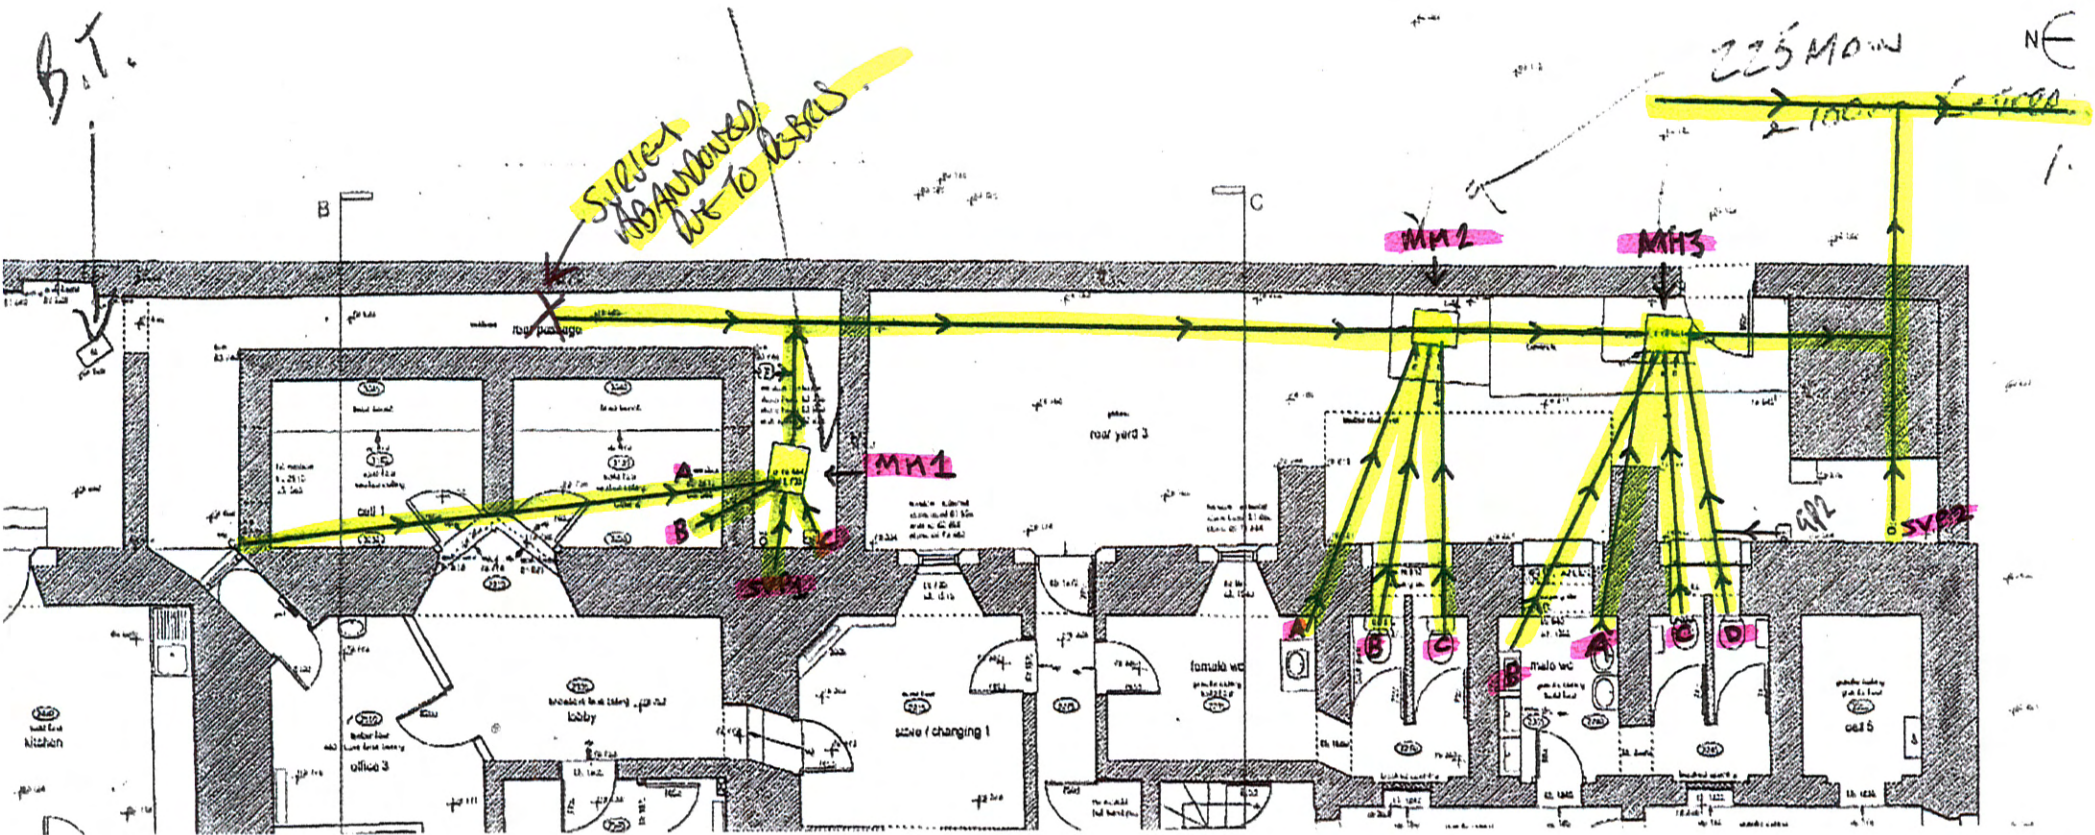
# TAUJISTOCK GUILD HALL & OLD POLICE STATION DETWAGE SURVEY

The main line going upstream from MH 2 we abandoned due to debris.

Surveyed downstream from MH 4 to the point of which it joins a main line, unable to proceed beyond this point due to sharp bend.

Highlighted on plans with dotted line of assumed route of drainage (unconfirmed).

This drainage could benefit from a routine clean throughout.

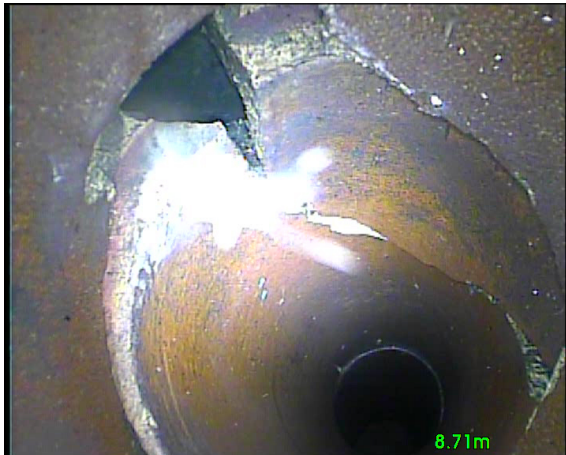
Photo: 16\_7A

| No. | PLR | Dir. | Use | Shape / Size | Date | Mat. | Total Length | Insp. Length | Peak HWG | Peak Score | Grade | Mean Score | Total Score |
|---|---|---|---|---|---|---|---|---|---|---|---|---|---|
| 16 | MH 4X | D | C | C 150 | 19/09/2012 | VC | 10.33 | 10.33 | 4 | 245 | 5 | 29.28 | 255 |

8.71m, Hole in drain/sewer, from 11 to 11 o'clock

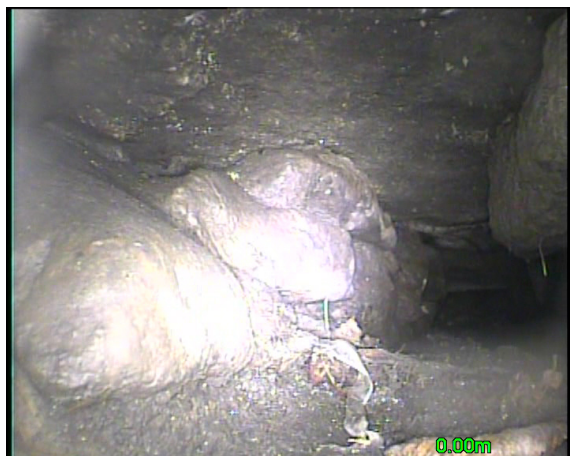
Photo: 17\_3A

| No. | PLR | Dir. | Use | Shape / Size | Date | Mat. | Total Length | Insp. Length | Peak HWG | Peak Score | Grade | Mean Score | Total Score |
|---|---|---|---|---|---|---|---|---|---|---|---|---|---|
| 17 | GP 4X | U | C | Z 200/200 | 19/09/2012 | BR | 0.00 | 0.00 | 3 | 5 | 4 | 0 | 5 |

0m, Settled deposits, fine, 30% cross-sectional area loss

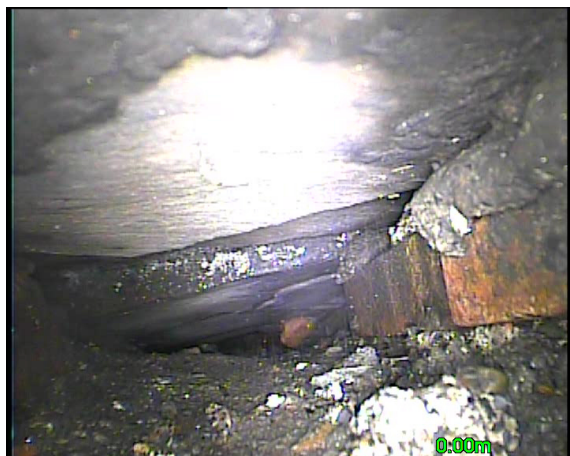
Photo: 18\_3A

| No. | PLR | Dir. | Use | Shape / Size | Date | Mat. | Total Length | Insp. Length | Peak HWG | Peak Score | Grade | Mean Score | Total Score |
|---|---|---|---|---|---|---|---|---|---|---|---|---|---|
| 18 | GP 5X | U | C | Z 200/200 | 19/09/2012 | BR | 0.23 | 0.23 | 3 | 5 | 4 | 0 | 5 |

0m, Settled deposits, fine, 50% cross-sectional area loss
