**Betsy Grimal Tower  
Tavistock  
Devon**

**2024 INSPECTION REPORT**

**Tavistock Town Council**

**Le Page Architects Ltd**

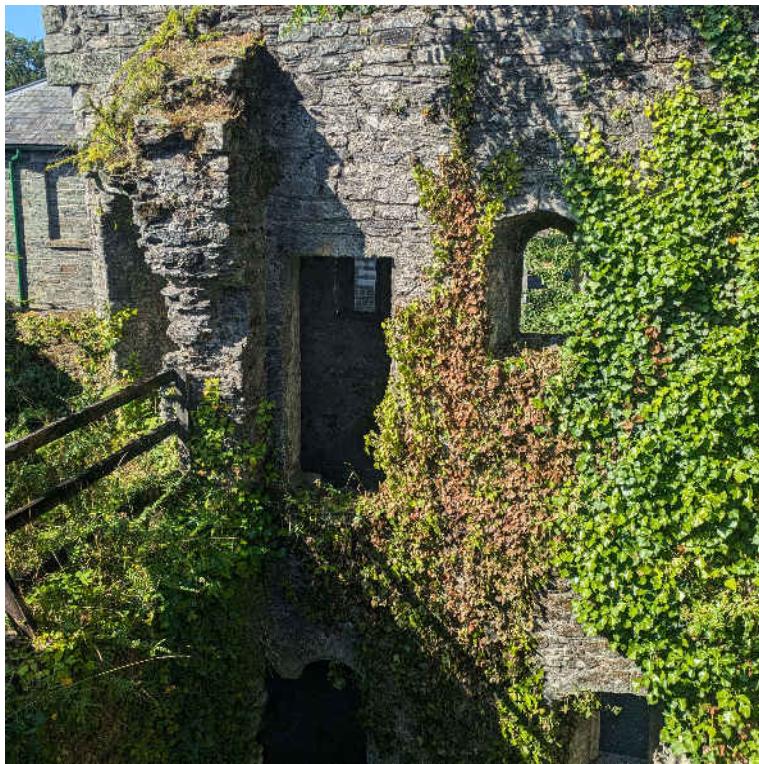
Image 01 - Internal view of south west elevation  
prior to full vegetation removal

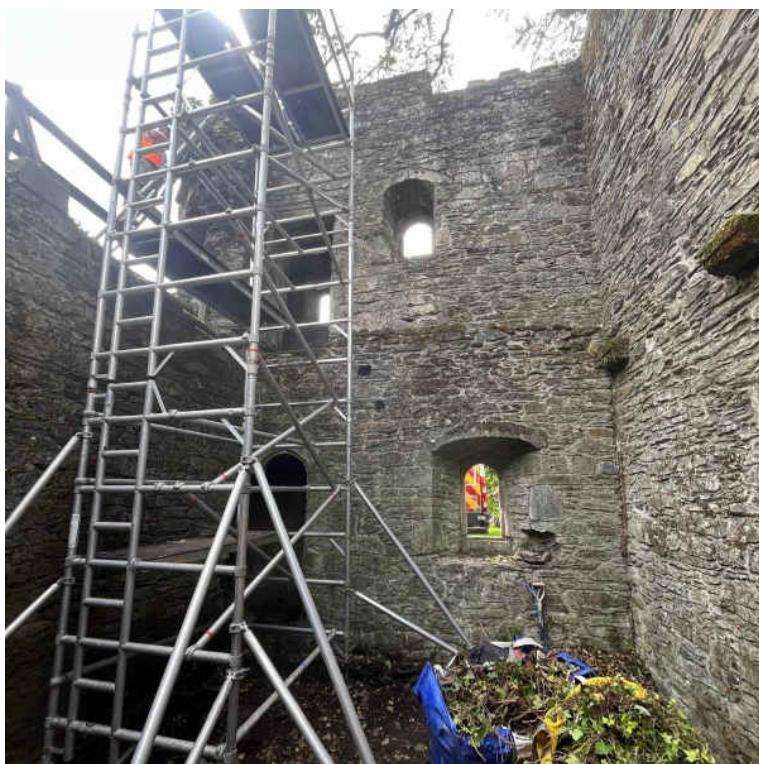
Image 02 - Internal view of south west elevation  
After large amount of vegetation removal

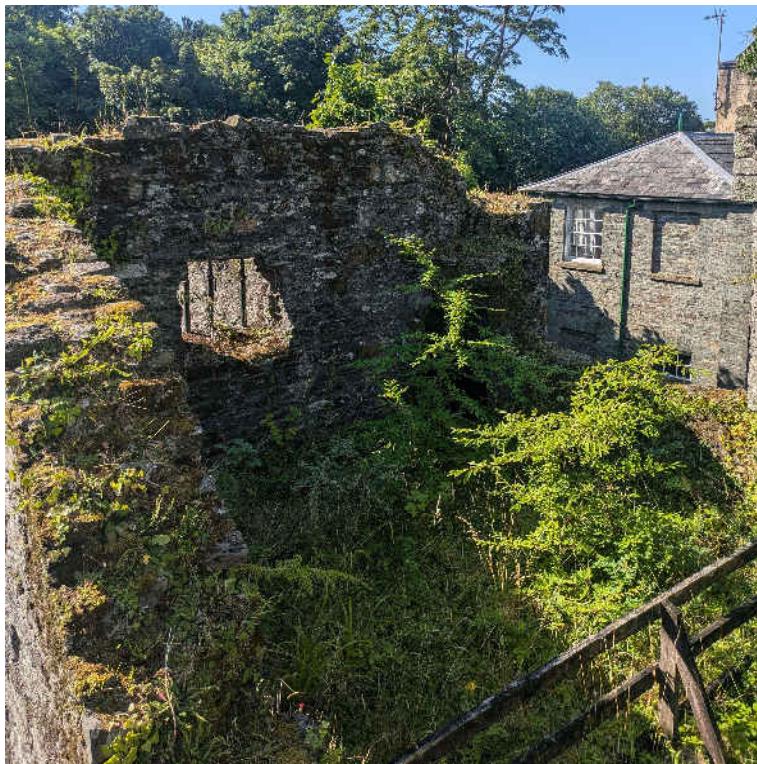
Heavy soil and vegetation to passageway floor over removed.

Image 03 - First floor  
Prior to vegetation removal

To passageway first floor over remove vegetation and soil to masonry level. Treat all roots within walls with suitable chemical weed killer. Ensure all soil and vegetation is taken from area to reduce future re-growth.

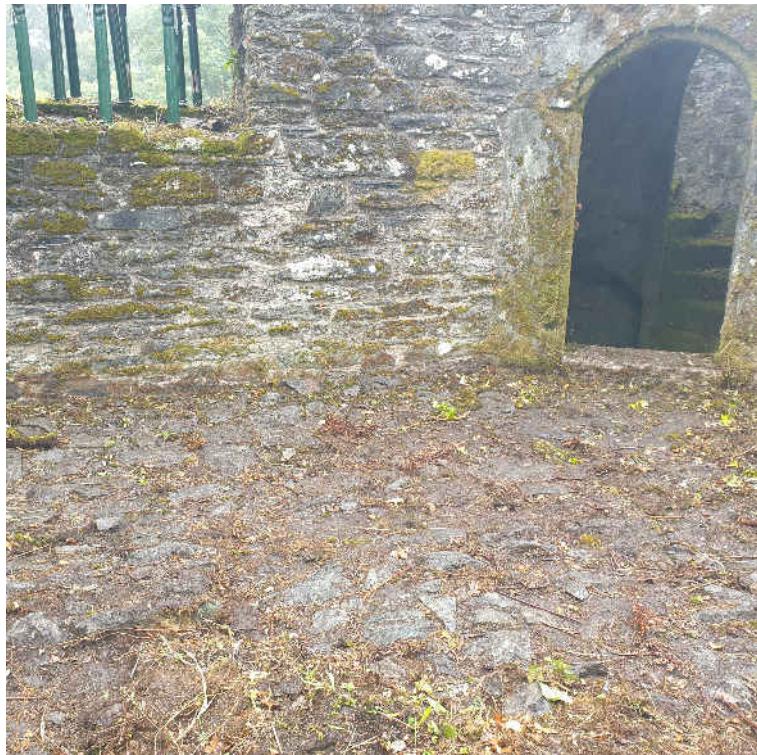
Image 04 - First floor  
Large amount of vegetation removed

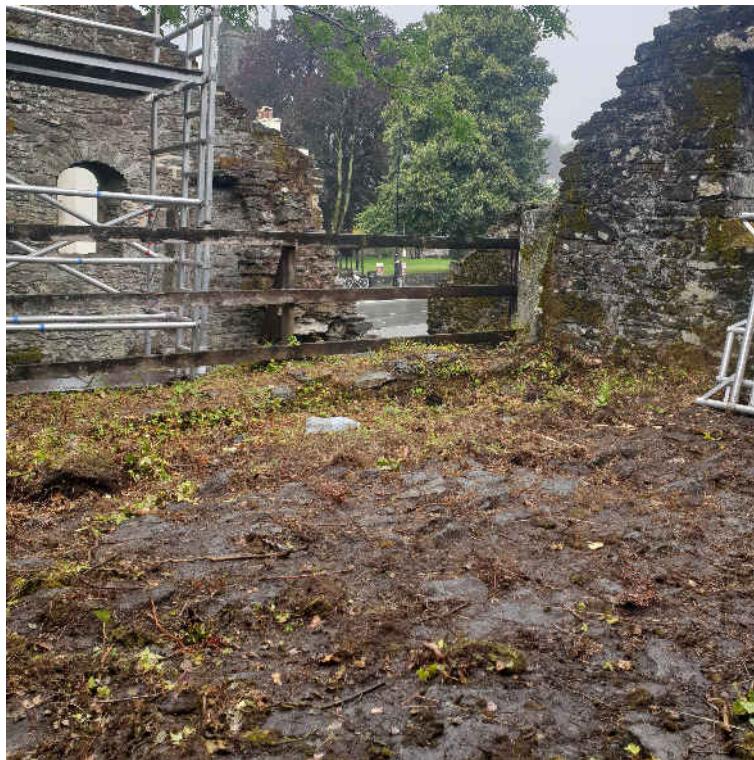
Image 05 – First floor  
After large amount of vegetation removal

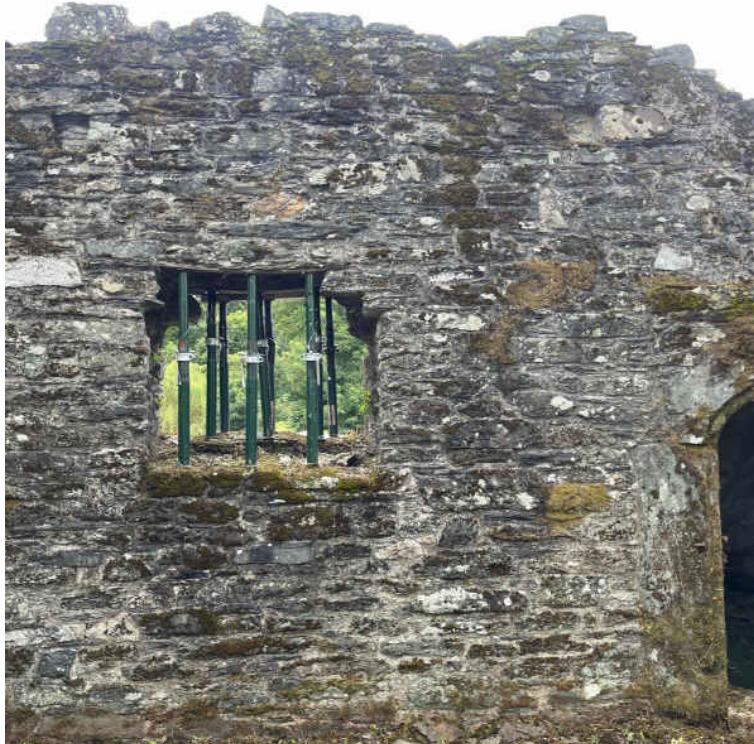
Missing lintel stone over upper window (missing dressed stone externally). Modern steel lintel bars in place now deflecting seriously. Temporary propped as part of the works.

Image 06 – Internal view of south east elevation  
Props installed to window

Consolidate upper south eastern window jambs and sill stonework. Schedule, photograph and number stonework to area. Remove stonework and set aside.

Carefully remove existing lintel bars to window head. Consolidate head stonework.

Incorporate new 316L stainless steel 75mm diameter prop with 150mm x150mmx12mm 316L stainless steel header and sole plates. All as Structural Engineer's details.

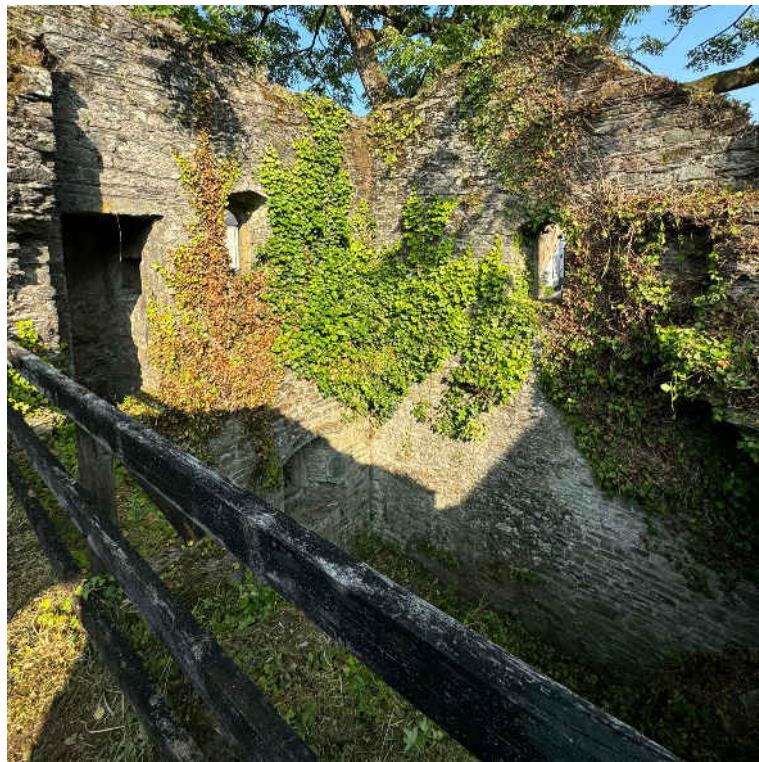
Image 07 - Internal view of north west elevation  
Midway through works with some ivy removed to lower levels

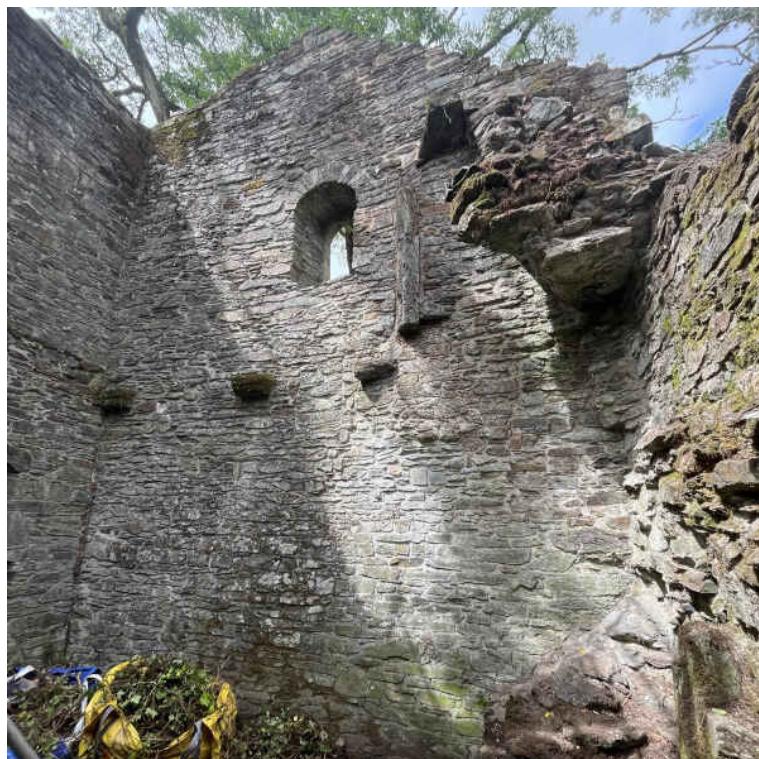
Image 08 - Internal view of north west elevation  
after large amount of vegetation removal and making good to some areas of stonework

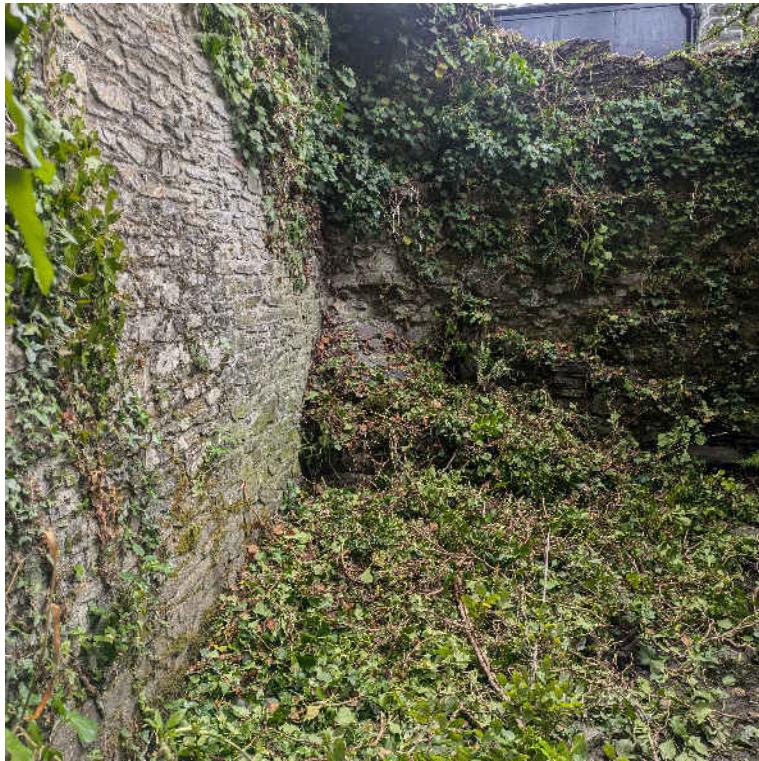
Image 09 - Ground floor and internal view of north east wall  
During the works still overgrown with vegetation

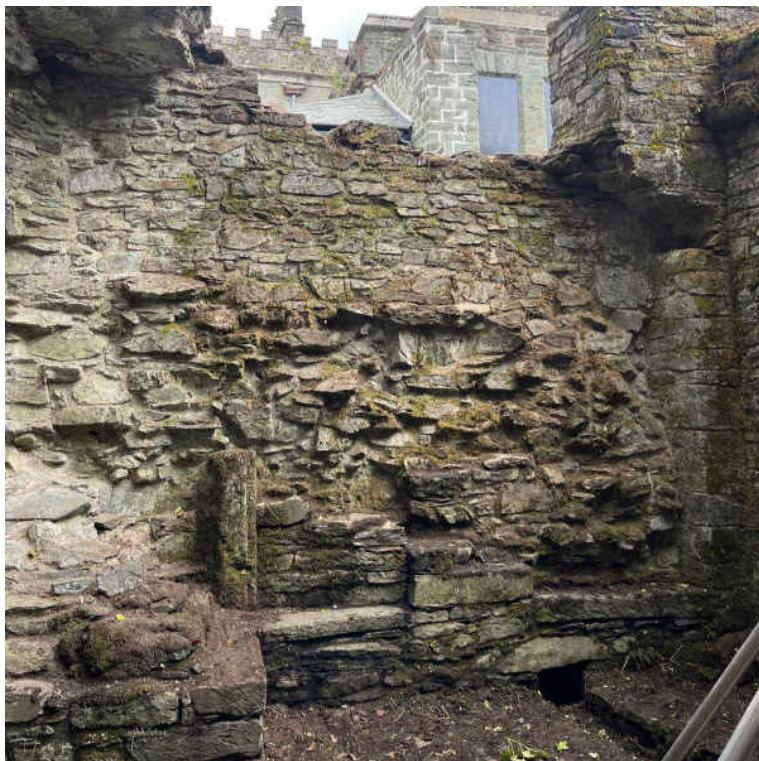
Image 10 internal view of north east elevation  
After large amount of vegetation removal

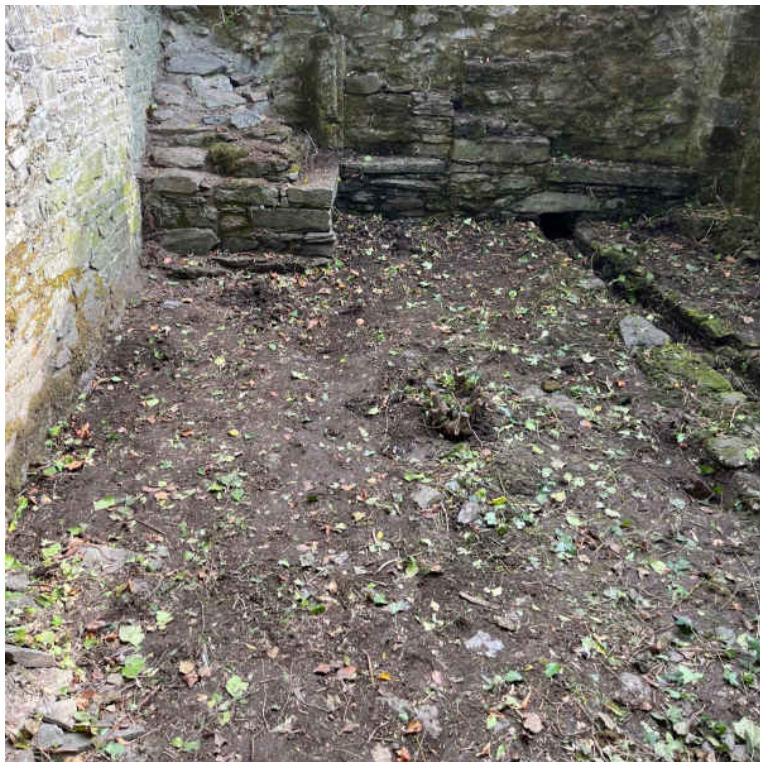
Image 11 - Internal view of ground floor  
with large amount of vegetation removed removed

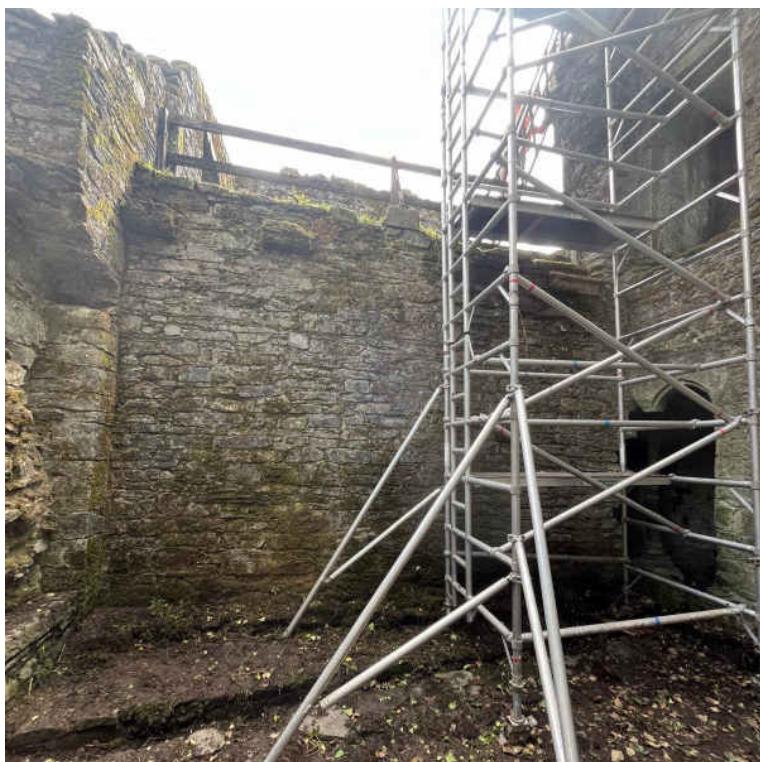
Image 12 - Internal view of ground floor & low level south east internal elevation  
after large amounts of vegetation have been removed

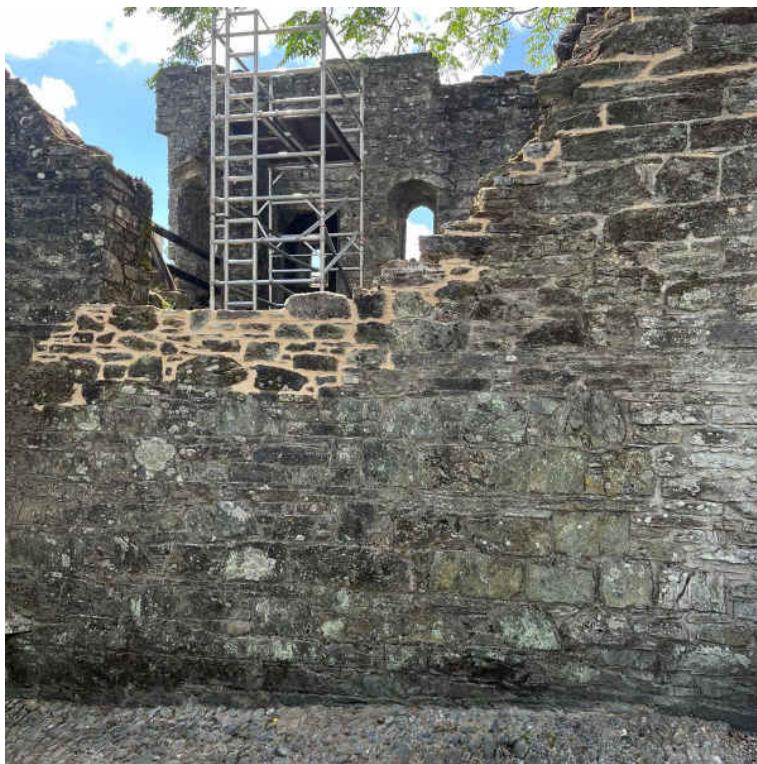
Image 13 - North east elevation  
Consolidation of high level stonework

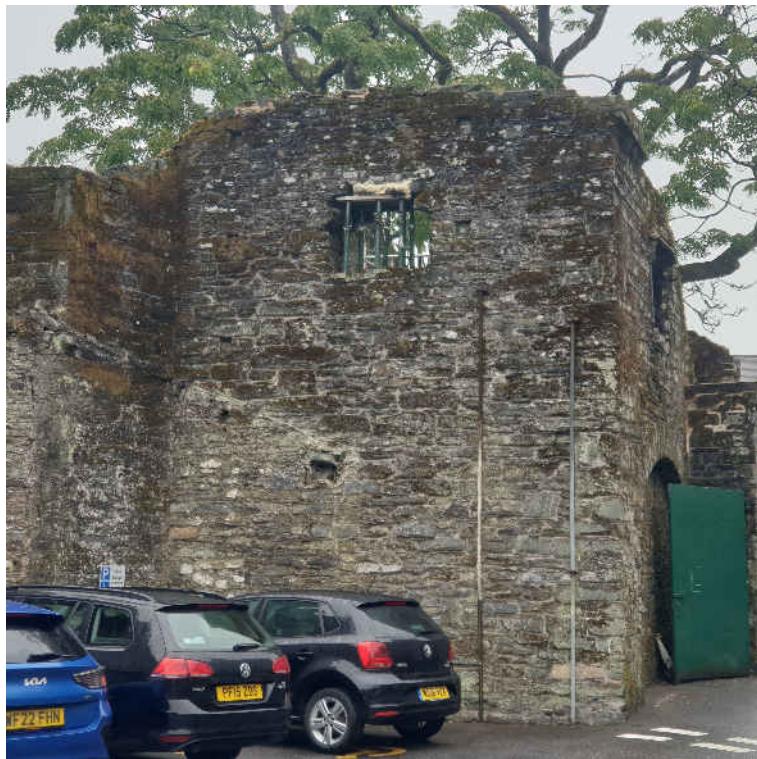
Image 14 - South east elevation  
after high level vegetation removal

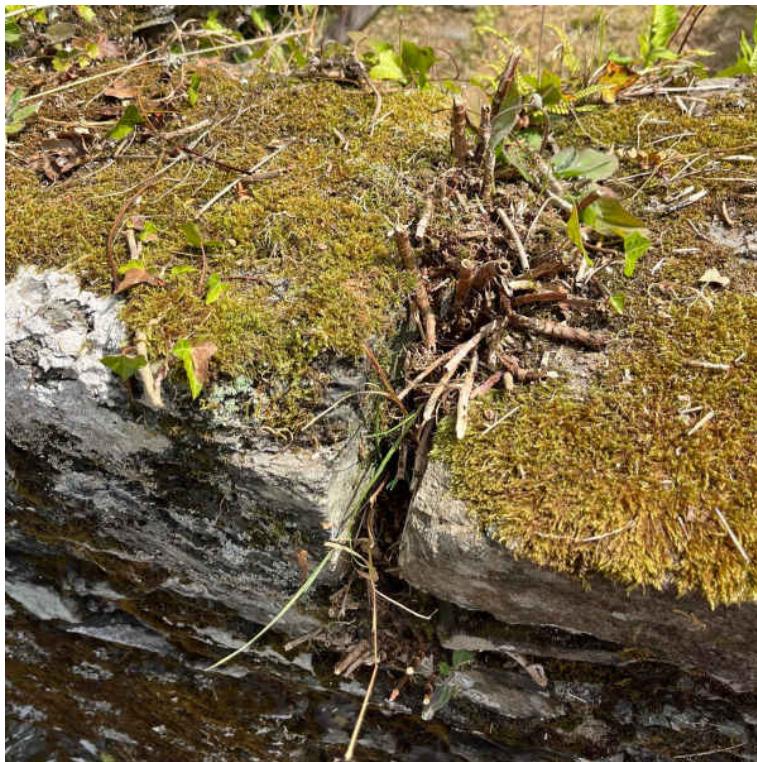
Image 15 – Top of wall to south west elevation  
Root to be removed

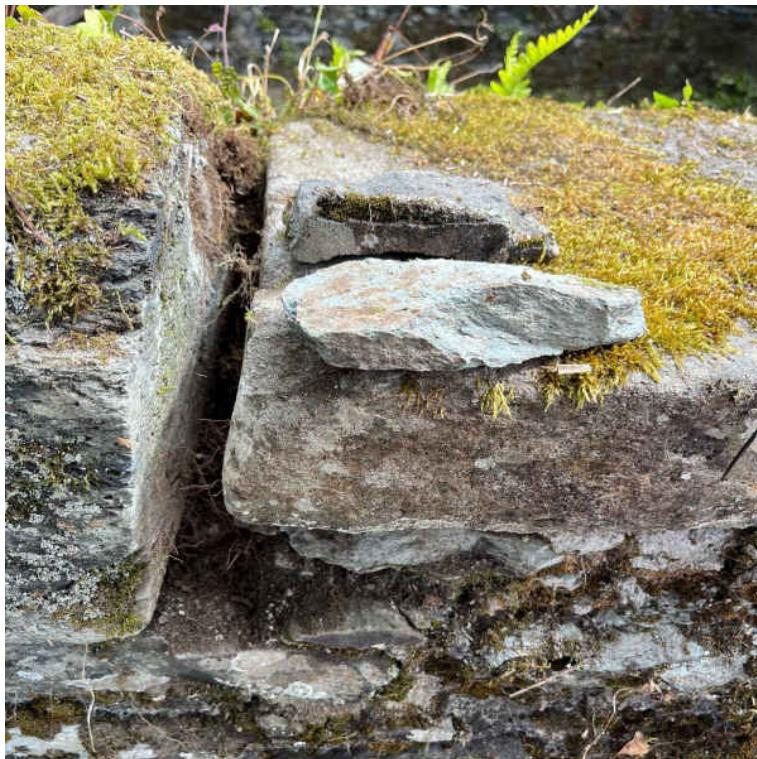
Image 16 – Top of wall to south west elevation  
Photo after root has been removed (prior to pointing)

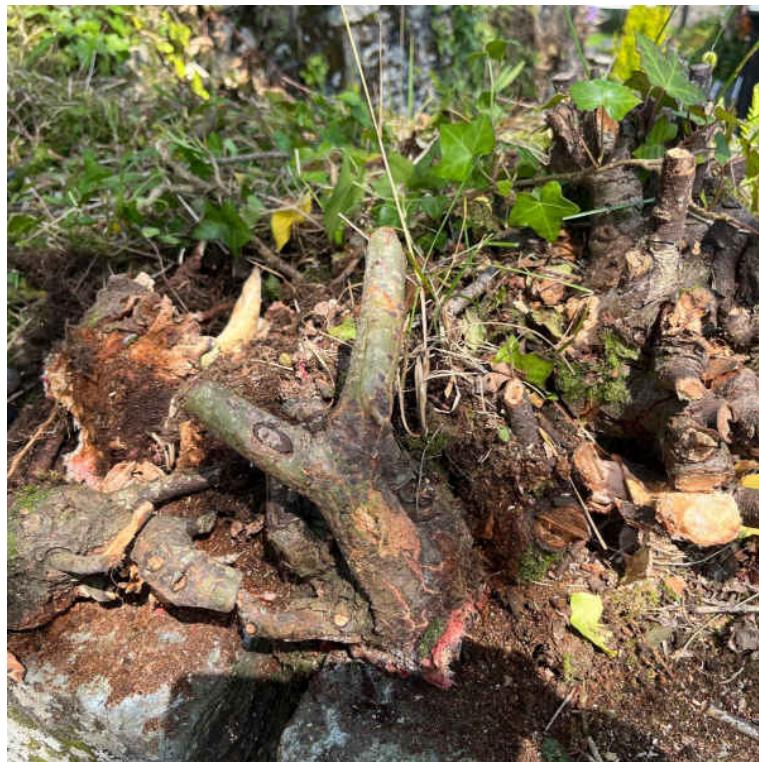
Image 17 – Top of wall to the south west elevation  
One of the roots removed

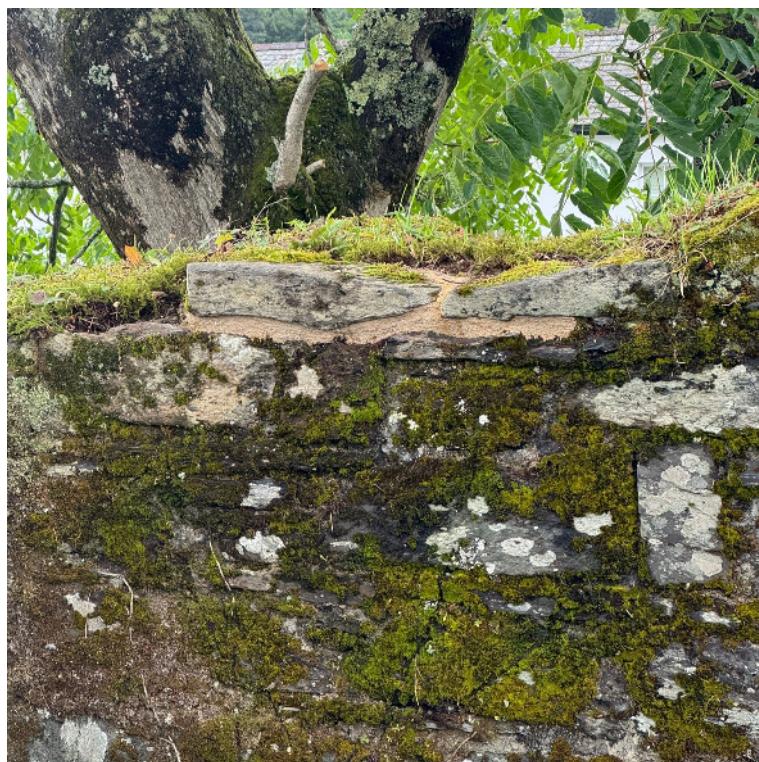
Image 18 – Top of wall to north west elevation  
Root removed and section of stonework removed and rebedded in lime-based mix

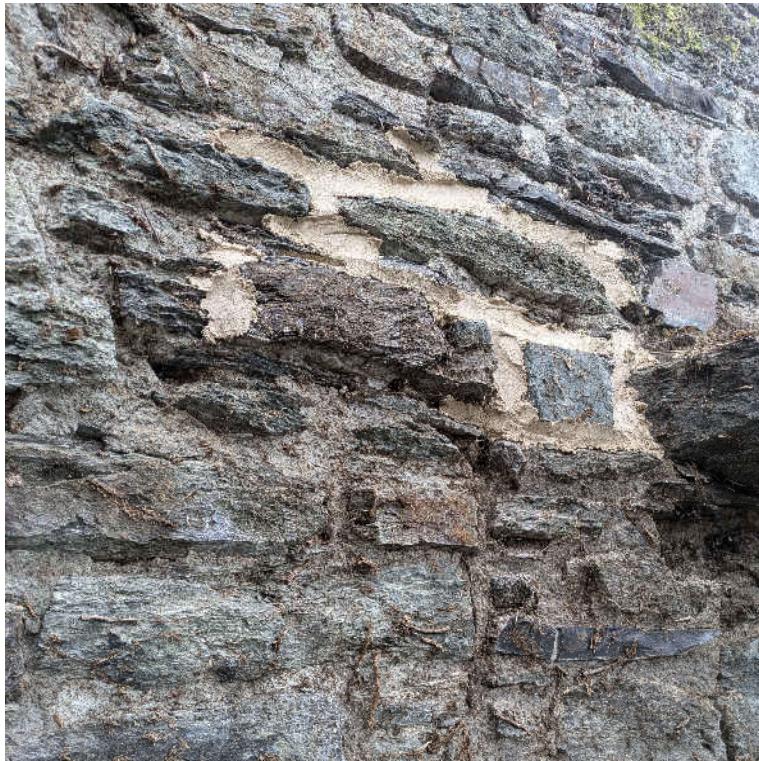
Image 19 – Internal face of north west elevation

Root removed and section of stonework removed and rebedded in lime-based mix  
(unfinished pointing at time of photograph)

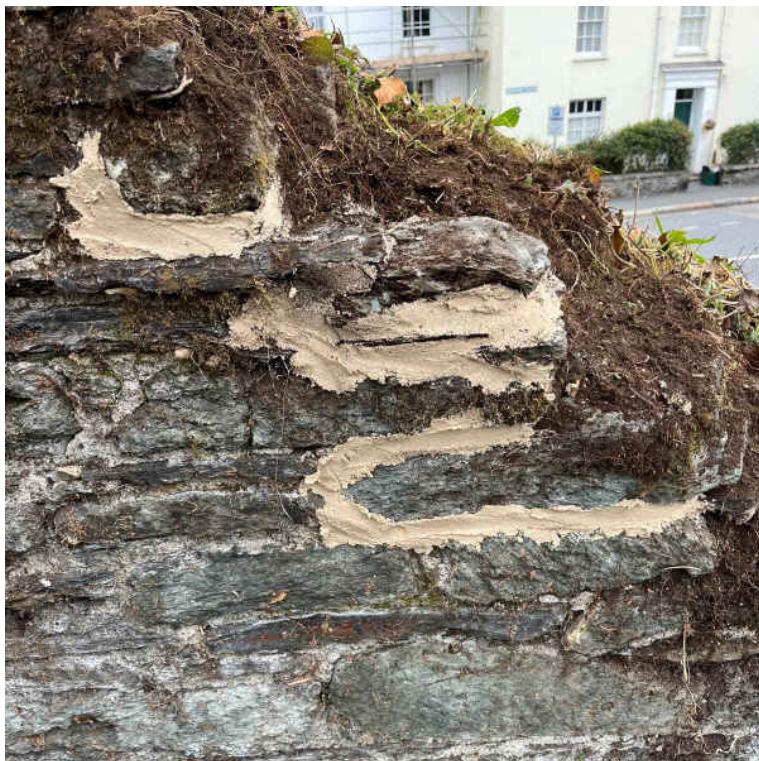
Image 20 – Top of wall to north west elevation

Root removed and section of stonework removed and rebedded in lime-based mix  
(unfinished pointing at time of photograph)
