**Still House Tower  
Tavistock  
Devon**

**2024 INSPECTION REPORT**

**Tavistock Town Council**

**Le Page Architects Ltd**

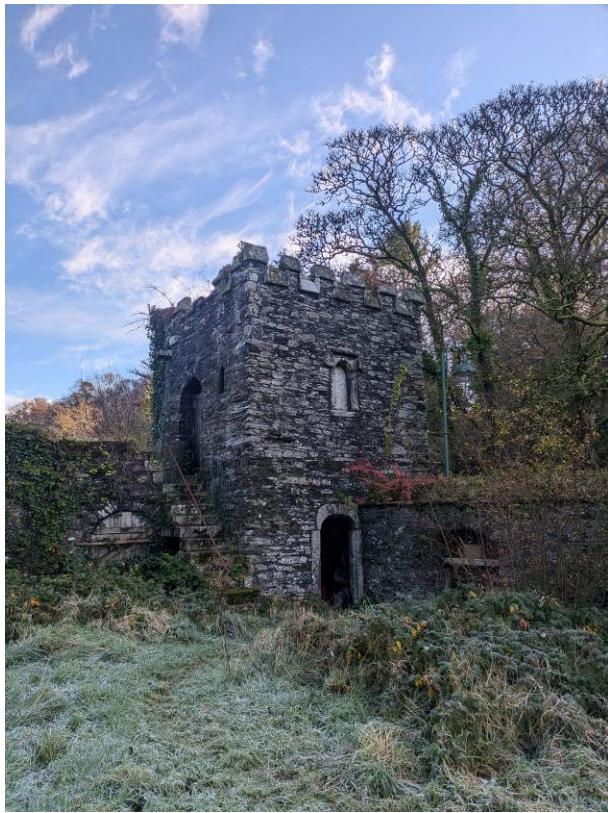
This elevation is again suffering from severe dampness particularly to its southern half (**image 1**).

View of the North-West Corner (**Image 1**)

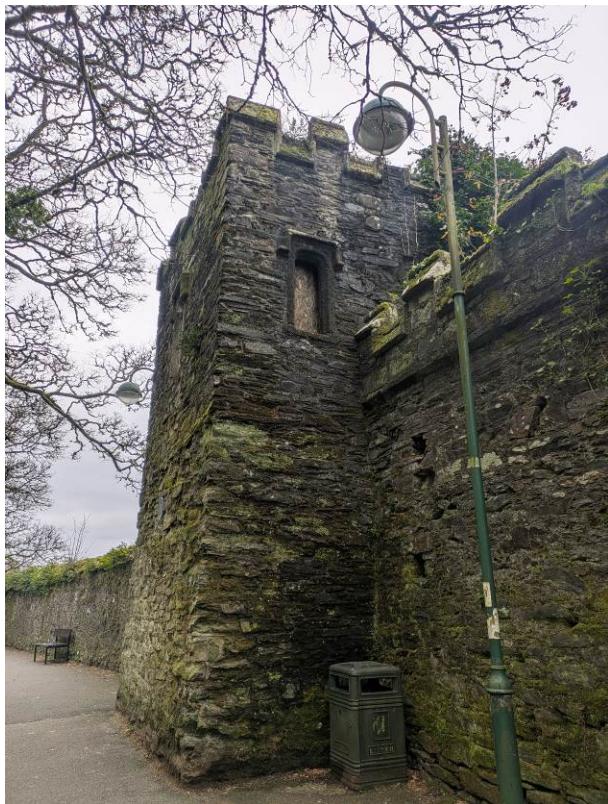
The upper wall section is severely damp (**image 5**) with extreme surface moisture to both the stonework and pointing, probably exacerbated by the large overhanging tree directly opposite. This tree inhibits access and it would be beneficial to trim it back from the building (**image 3**).

View of the South-East Corner (**Image 3**)

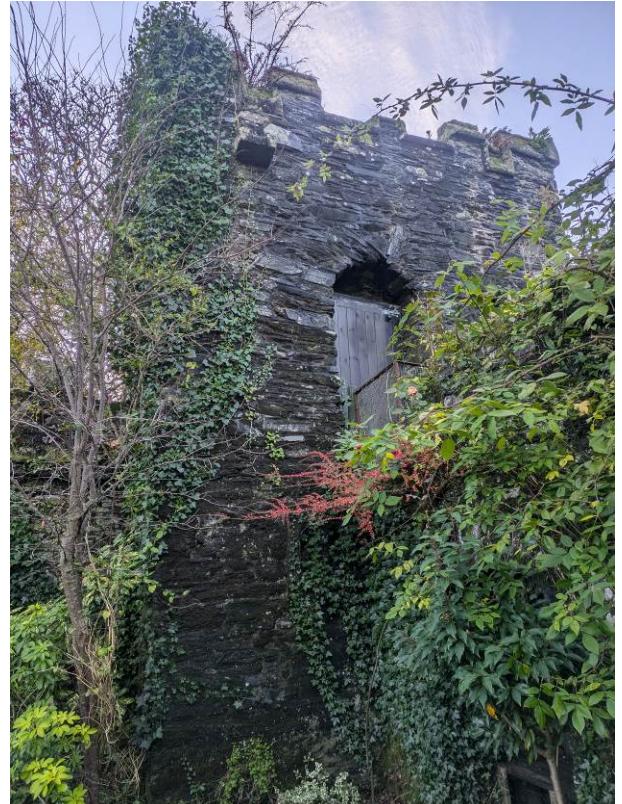
There is a substantial amount of ivy growth to the north-east corner of the building and access to the east elevation is restricted by the planting in the Bedford Hotel garden (**images 4 & 6**).

View of North Elevation from Hotel Garden showing  
Ivy Growth (**Image 4**)

Remove all vegetation, in particular the ivy growing to the north east corner. Treat all roots within walls with suitable chemical weed killer.

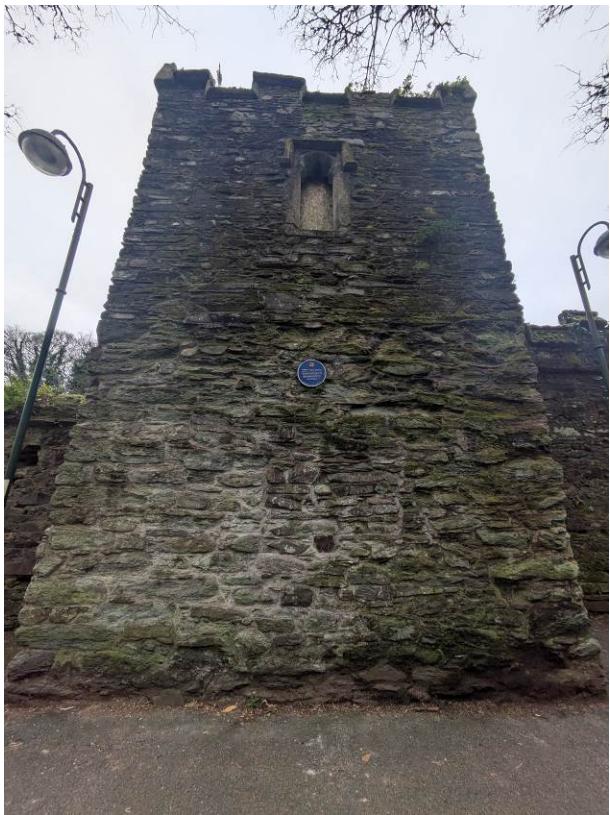
South Elevation with a large amount of Damp Stonework (**Image 5**)

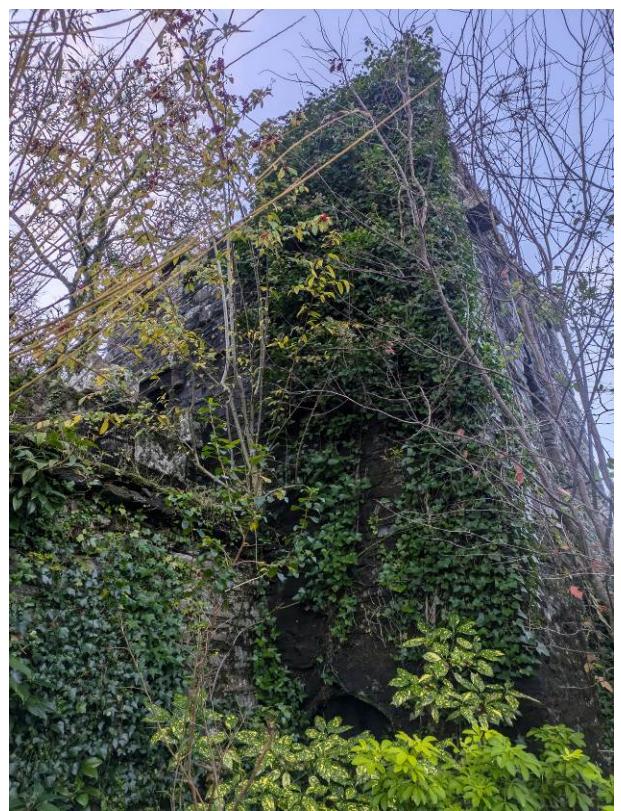
East Elevation (North Side) covered in Ivy (**Image 6**)

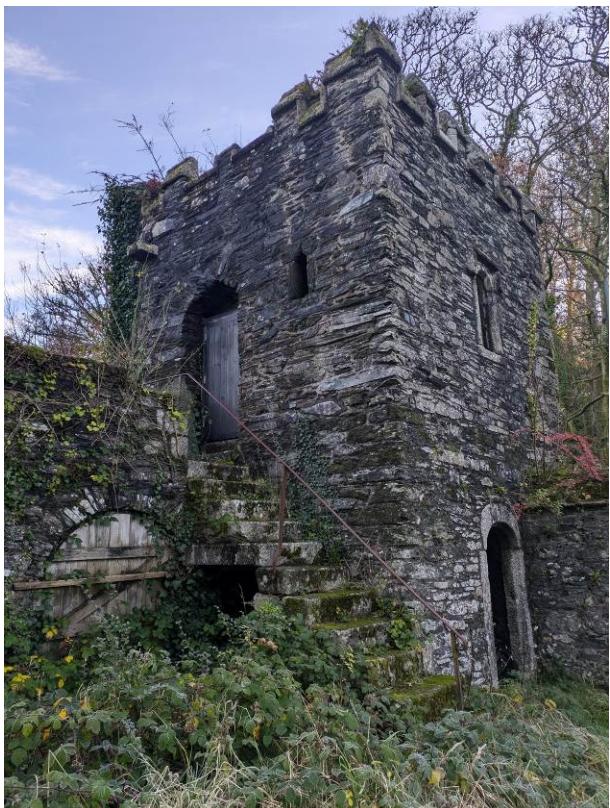
The walls are formed from Hurdwick random coursed stonework with granite tracery window, as well as dressed Hurdwick window and trefoil openings. This opening was not visible (externally) through the overgrown brambles surrounding it (**image 7**). Modern hard pointing in various locations with apparent recent lime pointing in patches mainly to upper southern corner and west of doorway. Some vegetation mainly to upper parapet stones, as well as ivy growth to the east of the elevation and along the stairs.

North Elevation (**Image 7**)

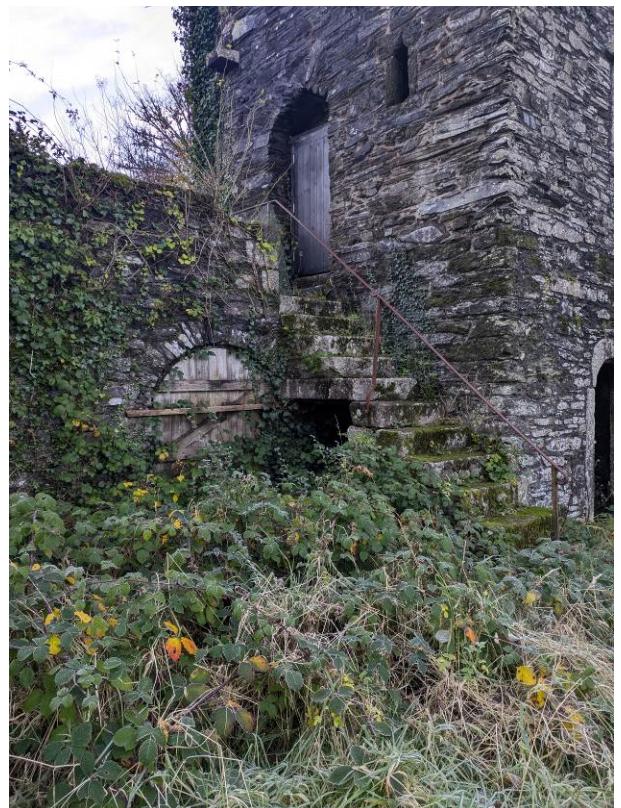
Main entrance door formed in Hurdwick stone with voussoirs over (**image 16**). Granite access steps leading up from ground level to doorway with granite threshold are in sound condition, but are heavily coated in vegetation, including ivy which has extended into the wall pointing adjacent (**image 8**).

Brambles adjacent to Steps on North Elevation (**Image 8**)

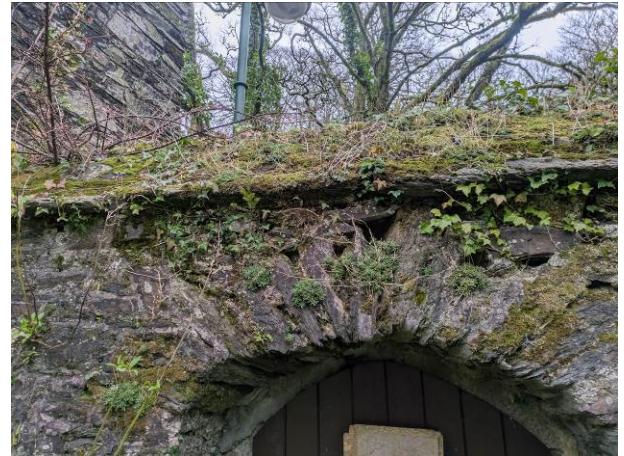
To the southern wall heavy vegetation occurs to its top situated above the granite framed door surround (**images 10 & 11**). Wrought iron door pins are present to the vertical granite. The door is formed from stained modern softwood in a ledge and braced design and is in good condition.

Large Gaps between Pointing to North Face of External Gate in Wall (**Image 10**)

Allow to rake out and repoint boundary wall to the west of the still house on both sides where pointing is missing and use stone shims to the open joints of the arch to the doorway and stone gallets to the larger open joints as required.

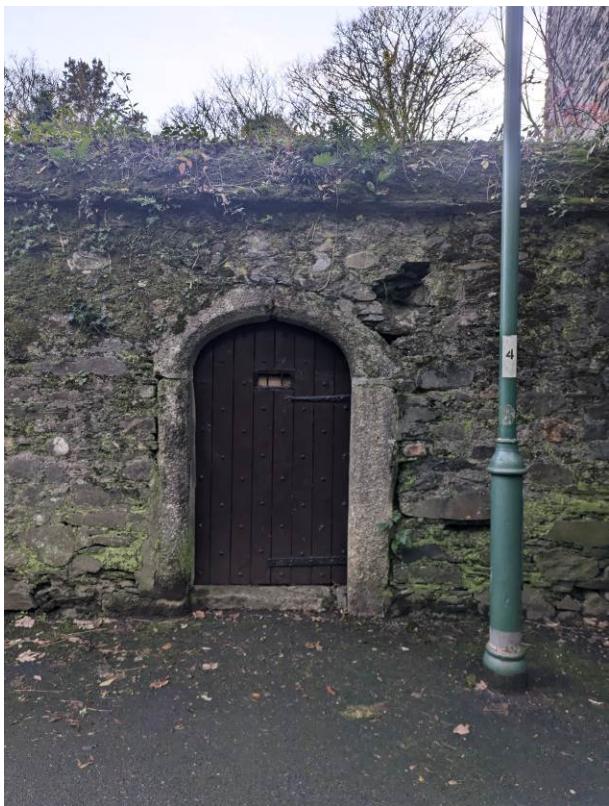
Gate to South Elevation with Sockets of Missing Stone to the Wall (**Image 11**)

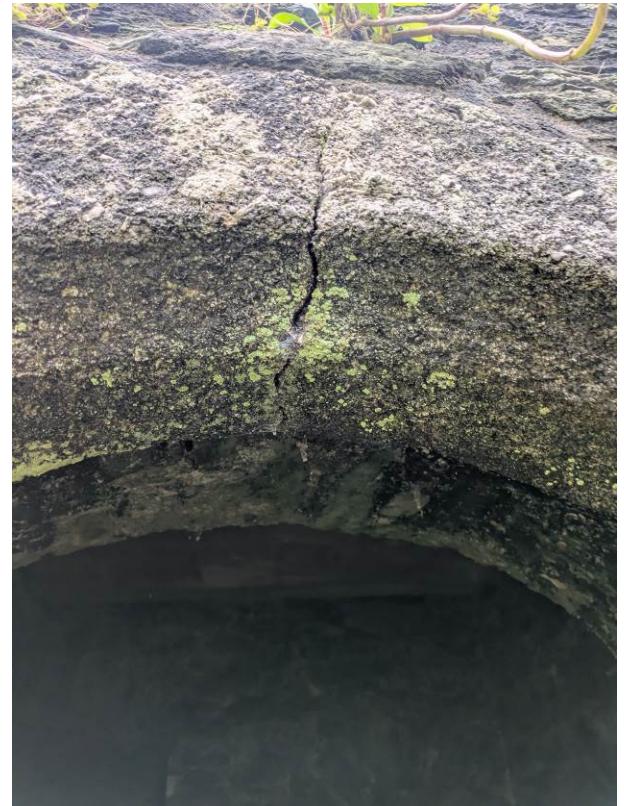
Granite tracery stone to the upper window as well as the ground floor door surround. A small crack was noted in the head stone to the granite door surround (**image 12**). There is hard cement pointing to the granite tracery surround to this door that is failing and needs replacing with a suitable lime-based mortar (**image 15**).

Northern window (**Image 12**)

Allow for pinning to head stone of arch on the opening to the west elevation where cracked.

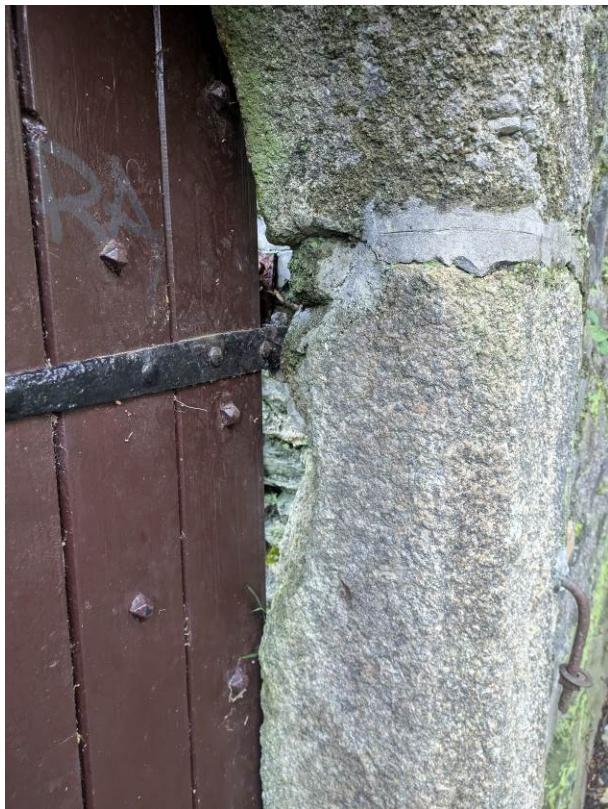
Sockets to the wall occur adjacent to the door opening as well as deep voids between the wall stonework and the granite surround pieces (**image 13**). There are patches of cement pointing to the granite surround of the door which are failing.

Damage to Stone Surround (Image 13)

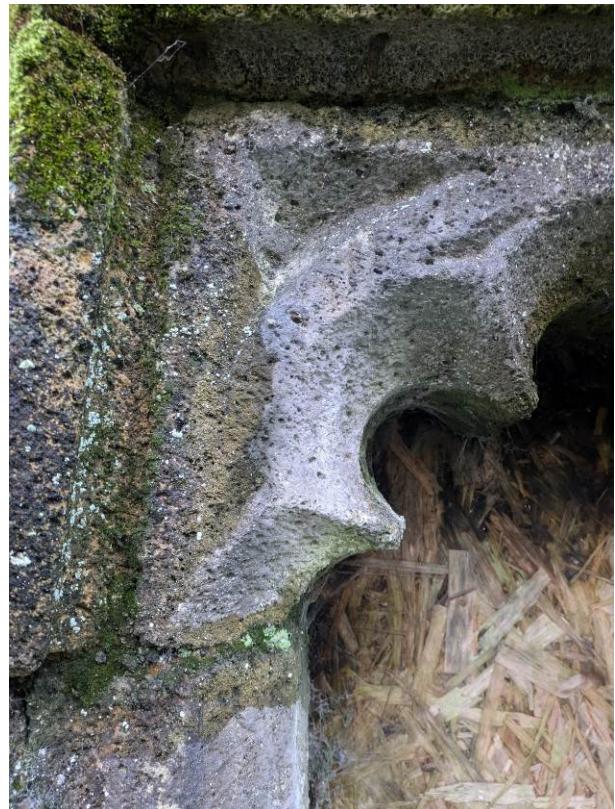
There is a single window opening to this elevation at the higher level, the stone although in sound condition does show signs of minor erosion (**image 14**) which should be monitored. The biological growth to the head should be removed as this will increase the speed of erosion (**image 19**).

Erosion to Tracery on South Elevation Window (Image 14)

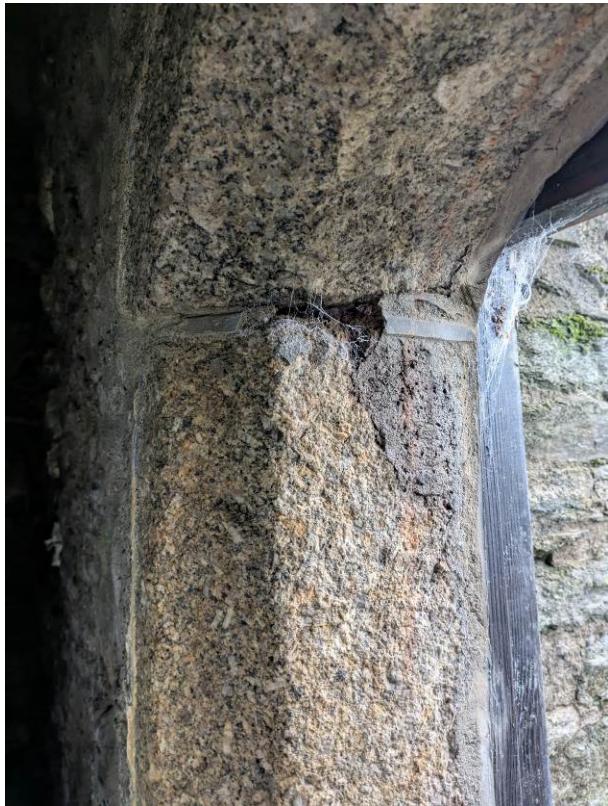
Failed Inappropriate Cement Pointing to Upper Storey Granite Door Surround (Image 15)

Allow to remove all modern hard mix cement pointing back to depth twice that of joint height(s).

Repoint all raked out joints in laboratory analysis based mix of NHL pointing.

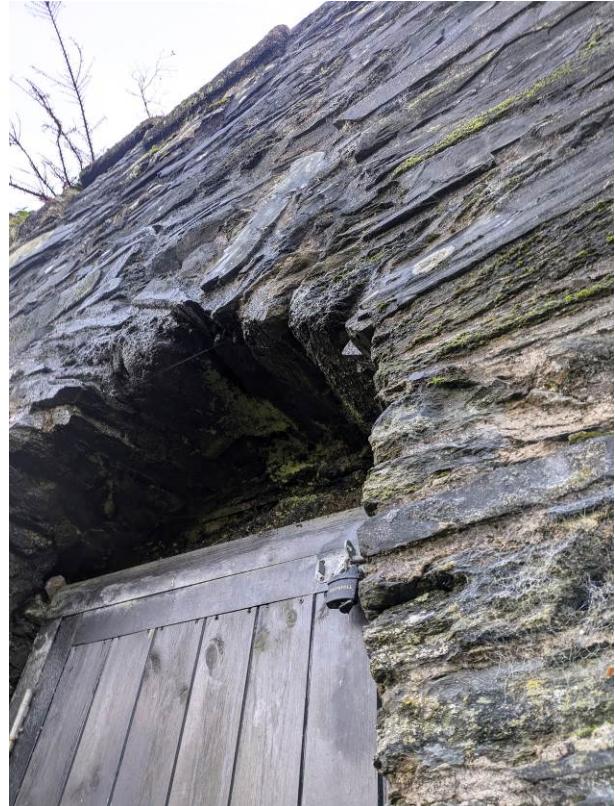
Stonework over Door to North Elevation (Image 16)

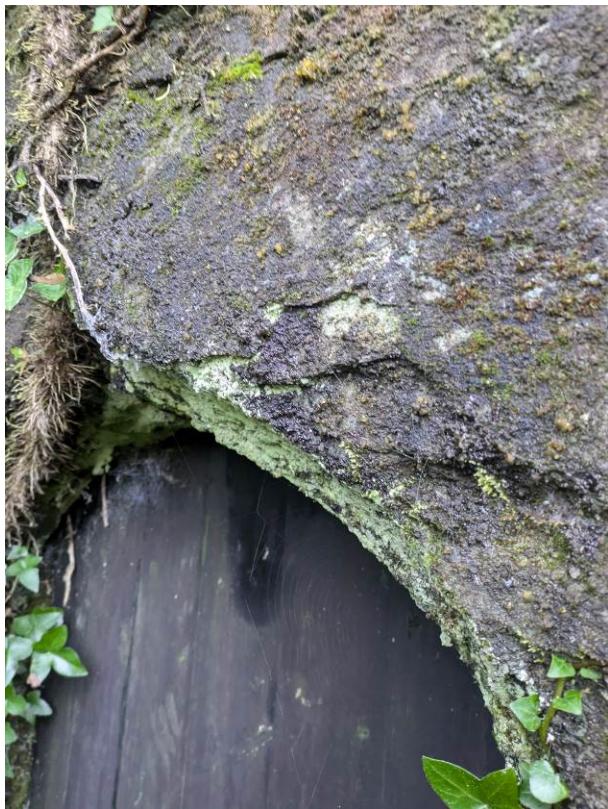
Tracery to Door on East Elevation Beginning to Erode (**Image 17**)

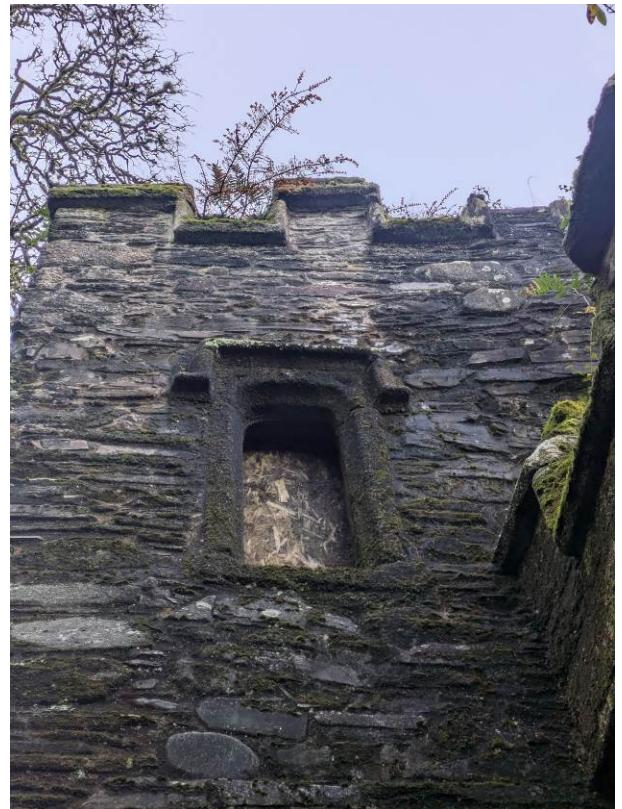
The upper storey windows have all been boarded from the inside with osb board (**images 18, 19 & 21**), this has become severely damp in places and although it deters unwanted entry into the building it is not a suitable long term solution and a suitable alternative is required.

Vousoir stones to former doorway, concaving and bulging of stonework noted (**image 18**).

Window to East Elevation with Bulge Adjacent (**Image 18**)

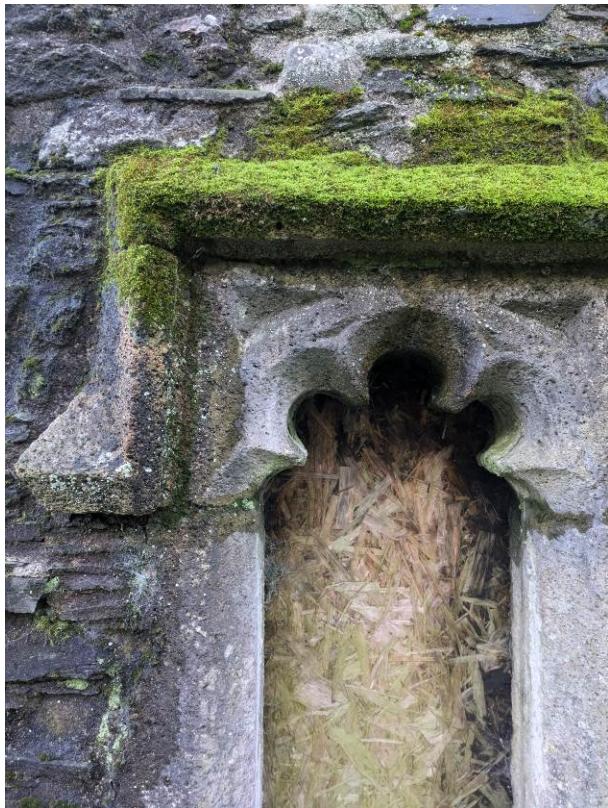
Window to South Elevation (**Image 19**)

Allow to Doff clean walls, in particular around the tracery to the windows where there is a substantial amount of biological growth, as well as the high level parapet stones.

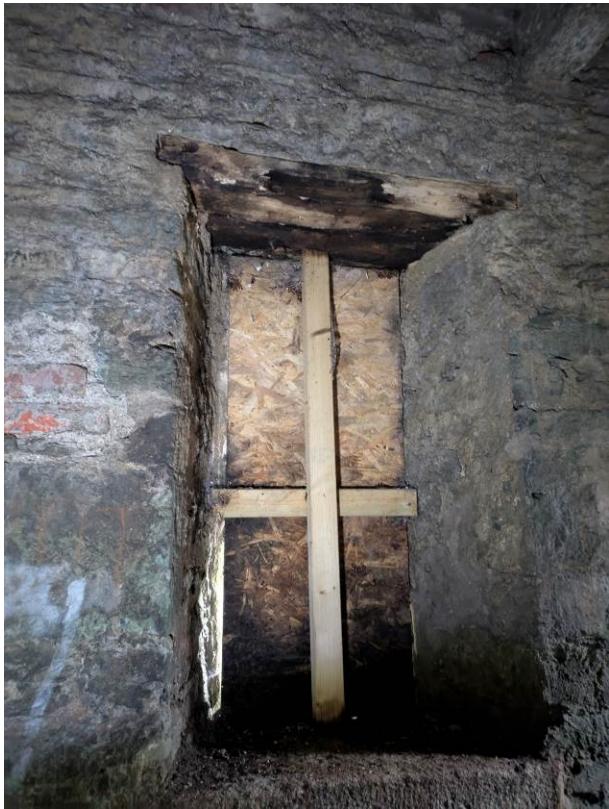
The upper face of the wall from corner to corner is damp and is probably the likely cause of the rotten timber lintel to the opening (**image 21**). Brick infills have been installed with cement mortar and appear to both sides of the window opening and to the lining of the former fireplace below. Granite corbels sit at roof deck level. Former flue to fireplace remains (partially).

Rotten Timber Lintel to Window in West Elevation  
**(Image 21)**

Remove all saturated osb board to window openings and replace with stainless steel bars to fit into existing sockets in tracery.

Replace rotten timber lintels to opening in west elevation at upper storey level.

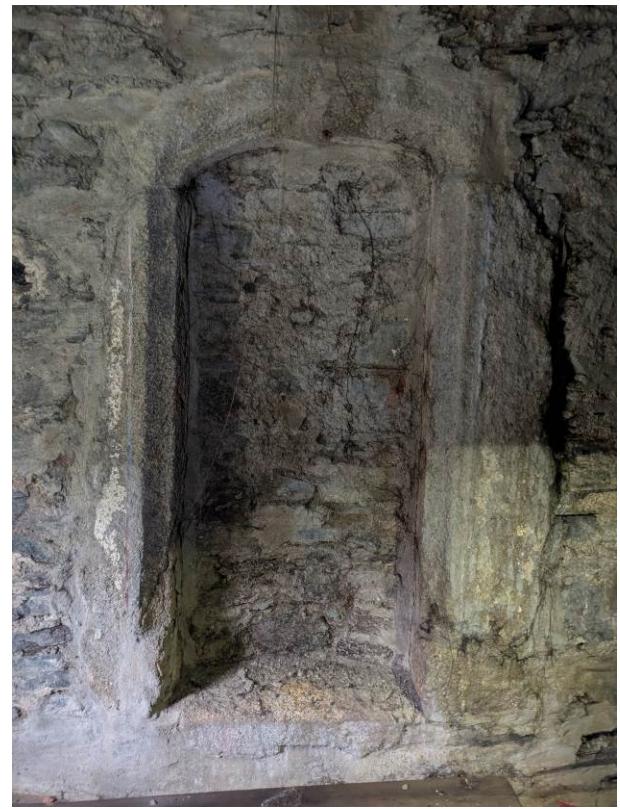
Evidence is clear to a large water ingress point to the roof joint to the upper north corner. The remainder of the wall is again severely damp, with large deposits of algae particularly to the former door recess where the stone faces are wet to the touch (**image 22**).

Blocked Door to East Elevation of Upper Level with Inappropriate Cement Slurry around it and Gaps in the Pointing **(Image 22)**

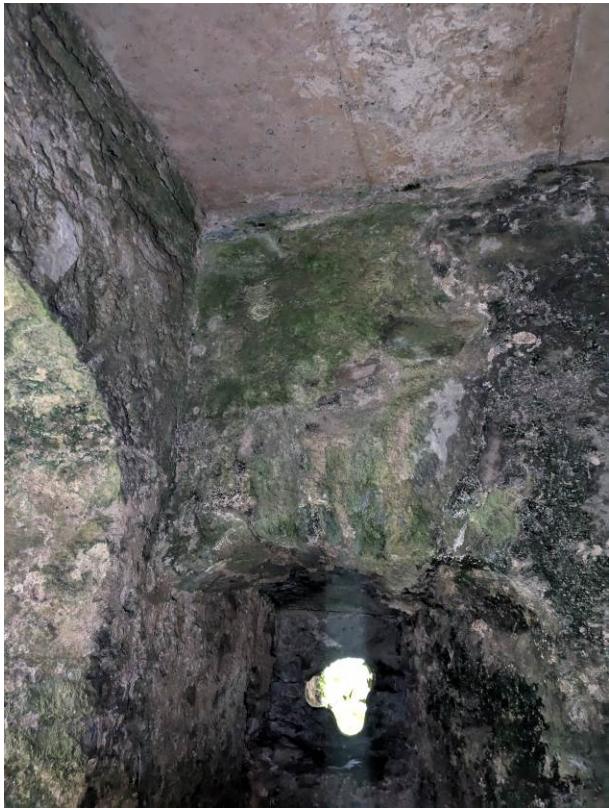
There are some gaps in the pointing to the internal arch of the small tracery window in this elevation that is in need of repointing (**image 23**).

Ground Floor View of the North-West Corner  
Showing Signs of Biological Growth and Damp Stonework **(Image 23)**

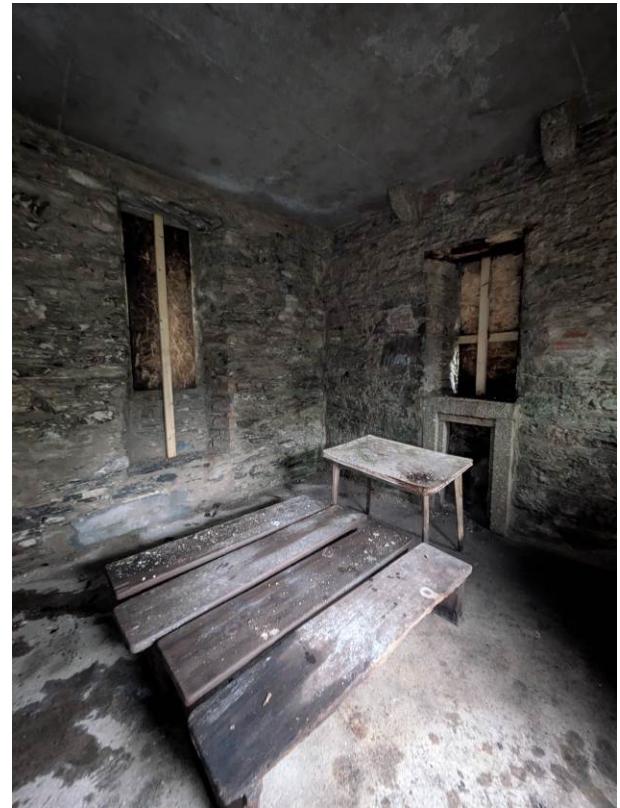
Surface damp to the wall face is evident (**image 24**) for most of overall area, with the moisture and algae growth clearly visible from the roof slab down two thirds of the face.

Internal View of South-West Corner **(Image 24)**

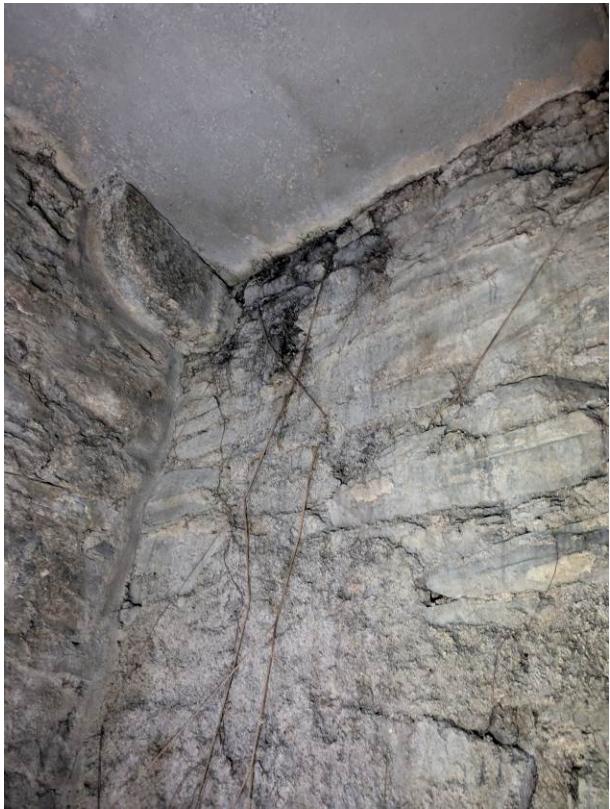
There are also roots coming in through the wall/roof junction from the vegetation growing on the roof and up the walls (**image 25**).

There are noticeable plant and ivy roots coming through the wall to this face, most likely linked to the vegetation growth on the wall and roof/parapet (**image 25**).

Roots coming into the east elevation and damp to high levels in the upper storey (**Image 25**)

Remove all vegetation to concrete deck and parapet wall tops. Treat all roots within walls with suitable chemical weed killer. Ensure all soil and vegetation is taken from area to reduce future re-growth. This should be carried out twice a year, as general maintenance of the building to prevent further harm being caused to the building

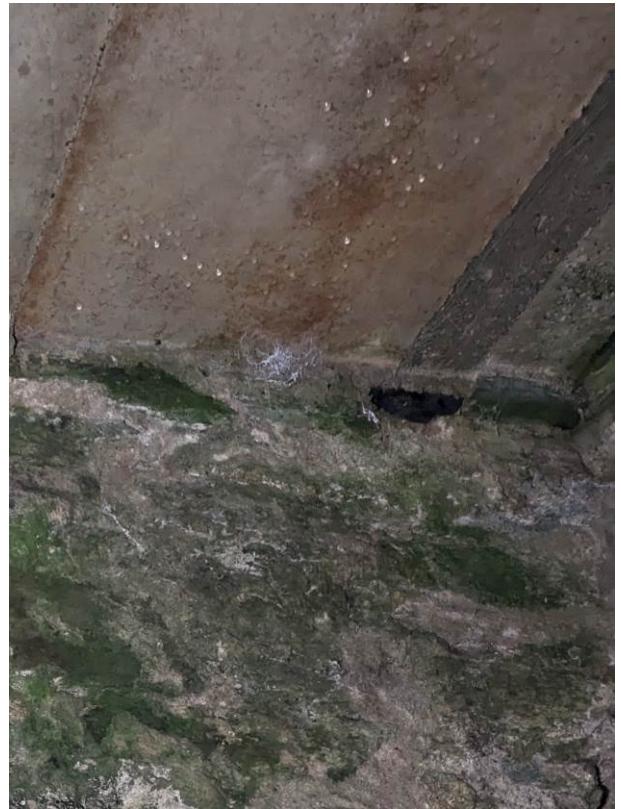
As in the previous inspection, the structure appears reasonably sound and is constructed from local Hurdwick stone with shillet being built over two phases (Exeter Archaeology Report). It is generally suffering from high levels of vegetation growth to the roof slab (**images 31 & 32**) and battlement wall tops, as well as substantial ivy growth to the north-east corner (**image 6**). As before, all elevations are suffering from dampness to the stonework both internally and externally. The modern inappropriate hard pointing mixes remain to all internal and external elevations. It was noted that the underside of the concrete floor/roof was dripping with water on our first visit (**image 26**) and internally there is a significant amount of damp.

Underside of concrete floor slab with droplets of water (**Image 26**)

Allow to repoint joint of modern concrete roof slab and parapet stonework in NHL 5 mix to arrest ingress of water to room below.

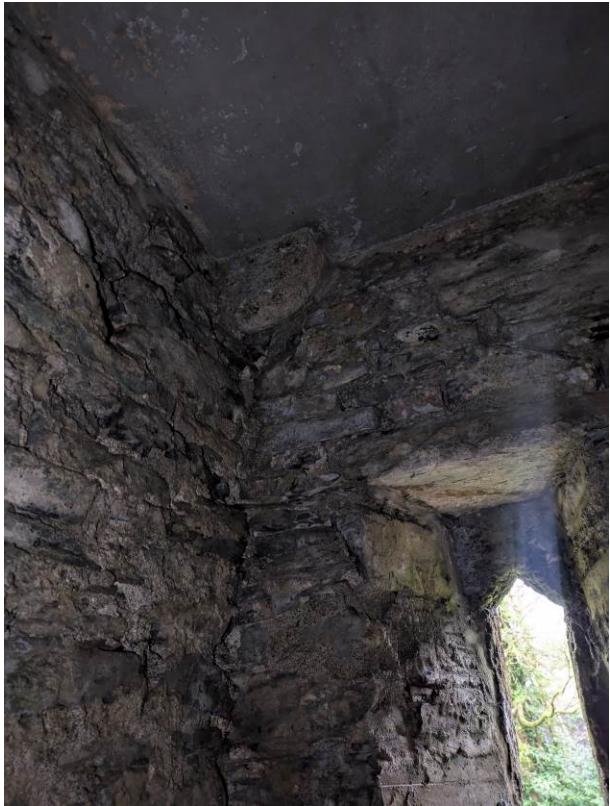
As before, the wall has severe internal surface damp to its face, and is evident for all of the overall area. In particular damp can be seen at the junction of the wall to the concrete roof slab over (**image 27**).

Upper storey north west corner showing missing pointing and evidence of damp (**Image 27**)

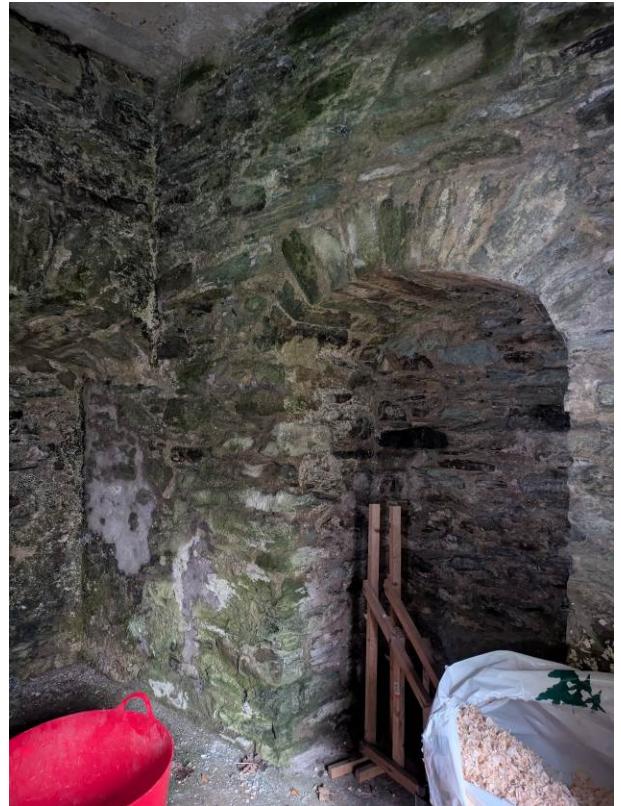
As before the previous notes still stand: Water ingress point can be seen to concrete slab over where wall below is damp to the touch, with high levels of algae and mould growth to all the wall area (**images 28 & 29**).

View of the south east corner at ground level (**Image 28**)

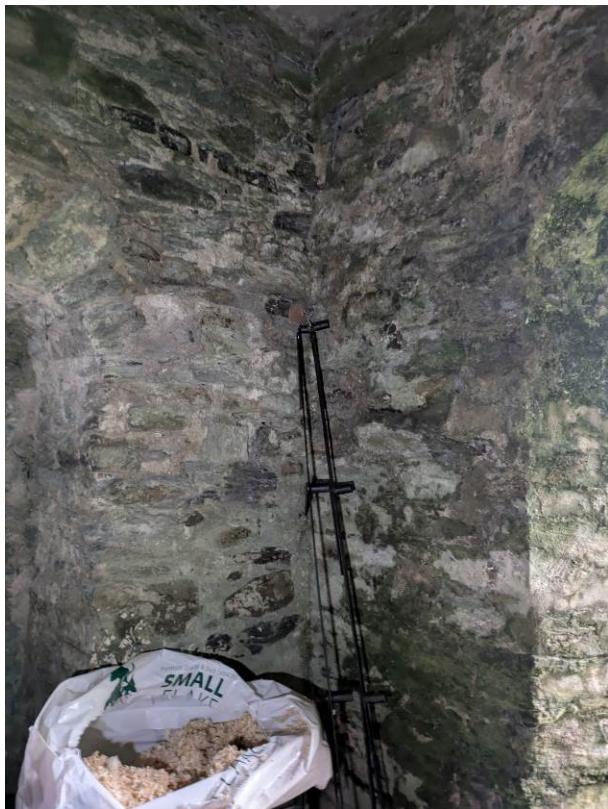
Some mould present to stonework and damp ingress from above can be seen at junction of concrete slab over (**image 29**).

View of the south west corner at ground level  
**(Image 29)**

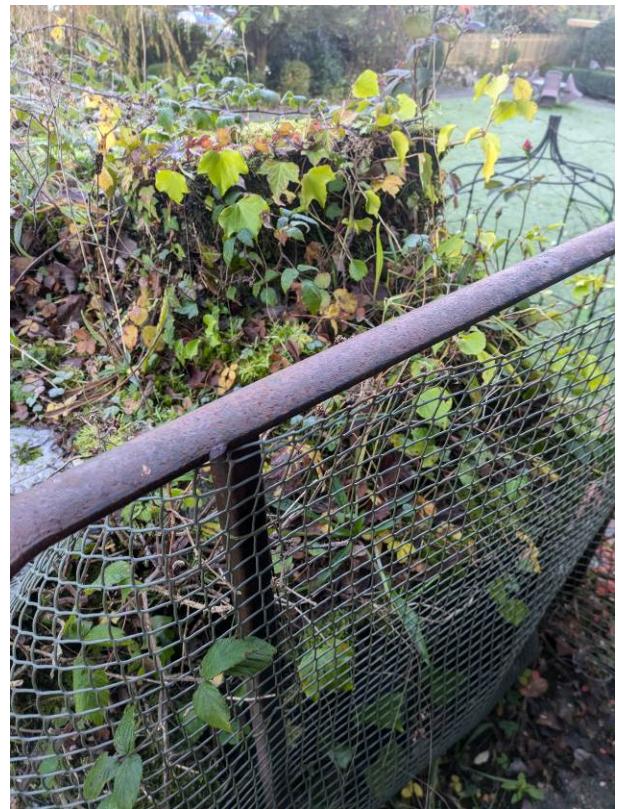
The steps are served by a wrought iron handrail and balustrade posts (**image 30**). These are in sound condition, but would benefit from re-decoration to protect it.

Railing to steps on north elevation **(Image 30)**

Allow to locally clean wrought iron handrail and balusters to ST2 standard. Paint in high quality external gloss paint system. Take a mesh barrier down the handrail of the steps all the way to ground level.

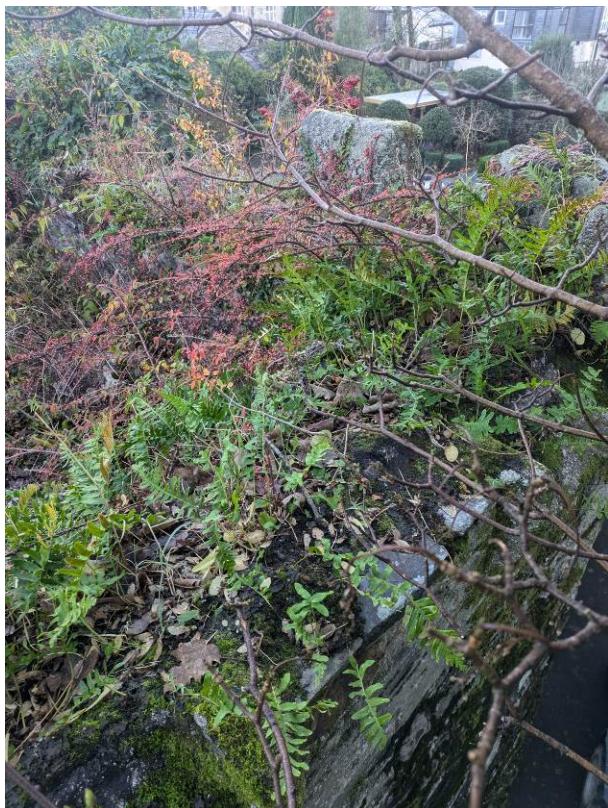
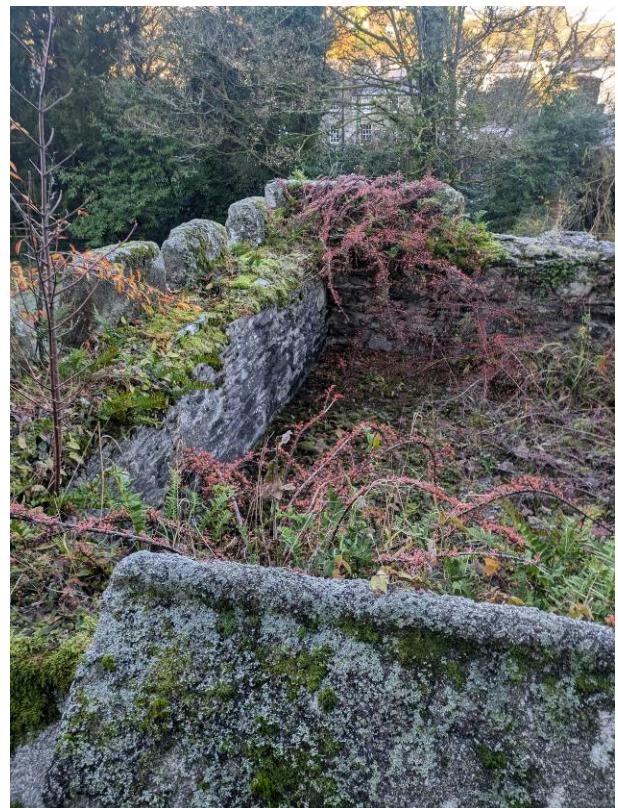
As previously noted, the walls are formed from similar stone to those of the main faces pointed in hard sand/cement mix. This is now starting to fall away in places where stone displacement is occurring. Wall tops remain covered with deep moss and there is a large amount of vegetation growing over the roof (**images 31 & 32**). Reviewing the images from the previous inspection in 2017, there is a noticeable increase in the amount of vegetation to the roof. This should be cleared to prevent further damage to the walls or roof structure.

View of the east side of the roof **(Image 31)**

View of the west side of the roof **(Image 32)**

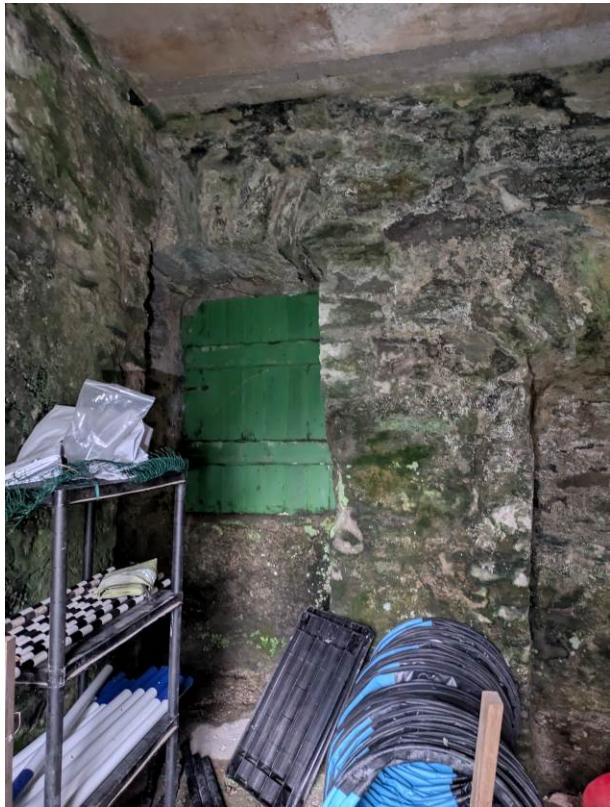
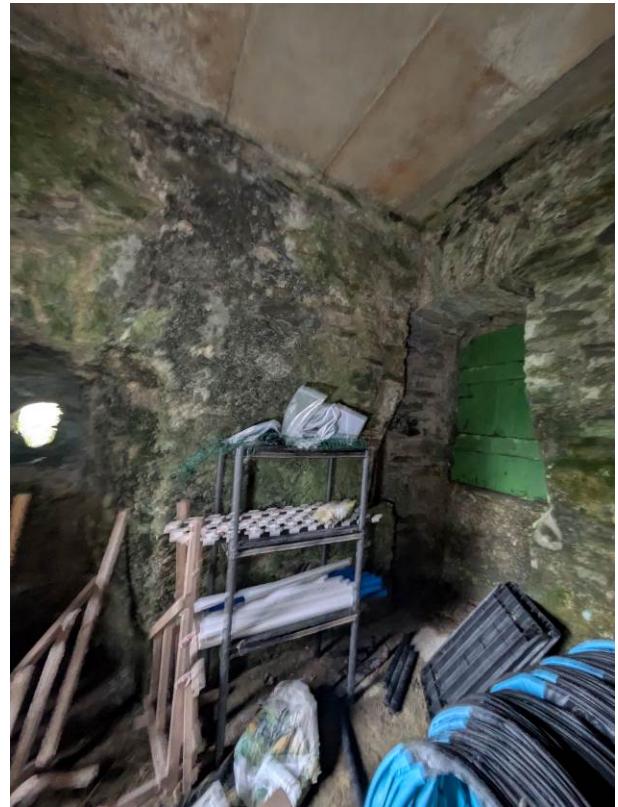
Large amount of algae and moss growth to masonry where damp (**images 33 & 34**).

Internal east elevation at ground level (**image 33**)

North east corner at ground level with biological growth (**image 34**)

Allow to doff clean down all internal wall, ceilings and floor faces of algae, moss and mould.
