Tavistock Guildhall and Police Station	date: October 2018	scale: 1:25@ A1 1:50 @ A3	drawn: cm	
drawing title: External Window Repair Schedule 6 - East Elevation	job no: 1041	drawing no: C-360	<sup>rev:</sup>	
gillespie yunnie architects				
Lower Tweed Mill Shinners Bridge Dartington Devon TQ9 6JB t 01803	860010 f 01803 864	929 e info@gyarchit	ects.co.uk

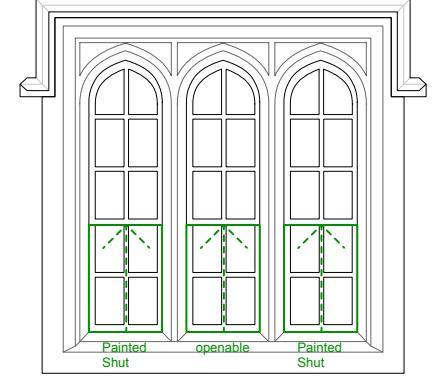
# Ref: 1W15

Location Trowtes House, First Floor Type Existing: Timber framed triple hung single glazed sash windows Proposed Works:

Rotten cill to be replaced in new hardwood, Rake out dead and defective putties and replace in linseed oil putty, cut out swollen joints and repair using window care repair if required Sash cords weights, staff beads & parting beads to be refurbished where required. Window and subframe to be prepared, with painted finish. Repair Code Code: 2

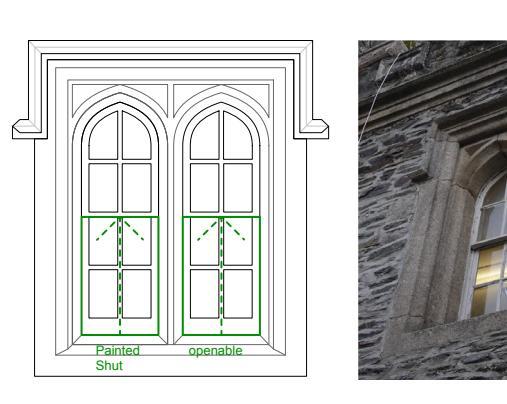
## Ref: 1W16

Location: Police Station, First floor Type Existing: Timber framed double hung single glazed sash windows Proposed Works: Rotten cill to be replaced in new hardwood, Rake out dead and defective putties and replace in linseed oil putty, cut out swollen joints and repair using window care repair if required. Sash cords, weights, staff beads & parting beads to be refurbished where required. Window and subframe to be prepared, with painted finish Repair Code: Code: 2 Glazing: Not required

Subframe/ surround: To all granite mullions and window surrounds, strip back all paintwork. Ironmongery: to be refurbished and/ or replaced where required. Finish: Paint windows with 2no. undercoats and finish with 1no. gloss finishing coat Colour: White - TBC External M60/123 Internal M60/150 Spec Reference: L10/**210** Comments - Option A: No Draught Seals - Option B: Draught Seal - weatherstrip around perimeter of sashes / recessed brush seal to sash meeting rail.

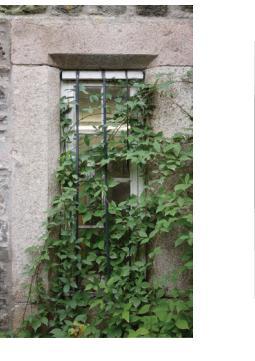
# Ref: GW11

Location: Courtroom, Ground Floor Type Existing: Timber framed single glazed window Proposed Works: Rotten cill to be replaced in new hardwood, Rake out dead and defective putties and replace in linseed oil putty, cut out swollen joints and repair using window care repair if required. Window and subframe to be prepared, with painted finish. External Vertical metal bars over window to be carefully removed, any damaged surrounds to be made good. Repair Code: Code: 3 Glazing: Not required
