# ARBORICULTURAL METHOD STATEMENT

Document reference: 407CTC0326\_5837\_Arbicultural\_Method\_Statement\_v1.0

Document title: Arboricultural Method Statement (AMS)

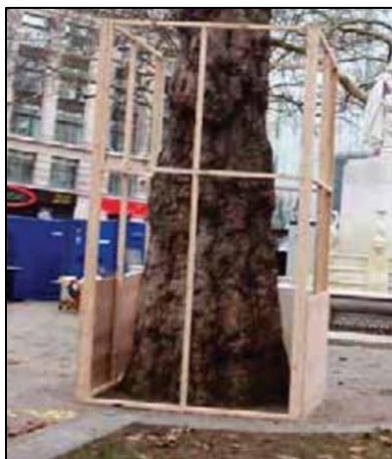
**Figure 2.02 – Example of a wooden frame to support sheets.**

The tree trunk protection will comprise of a self-supported timber frame (Figure 2.02) around the entire trunk of T0099. A metal framework of scaffold tubing could be used as an alternative to a timber frame.

This framework must not be fixed or rested on the tree's trunk. The tree trunk protection framework must avoid being positioned on exposed surface roots and/or buttressing and this must be compensated/mitigated for appropriately by being of adequate dimensions.

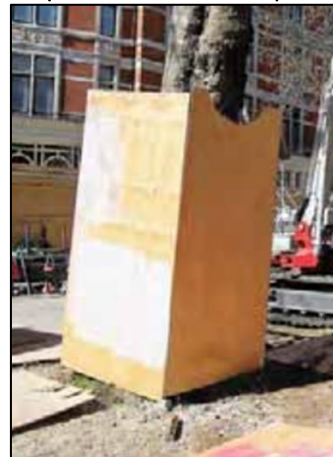
**Figure 2.03– Example of final tree trunk protection measures.**

Plywood board sheets of sufficient size and thickness will be fixed to the framework on the southern and eastern quarters of tree's (T0099) timber protection framework to form a partial surround in order to reduce accidental impact from scaffold erection.

The tree trunk protection must be installed before any scaffolding is erected on Site and remain in place until the restoration works have been completed and scaffolding has been safely dismantled and removed from Site. Tree Trunk protection must not be removed or altered without prior consultation with the Project Arboriculturist and, where necessary, approval from the local planning authority.

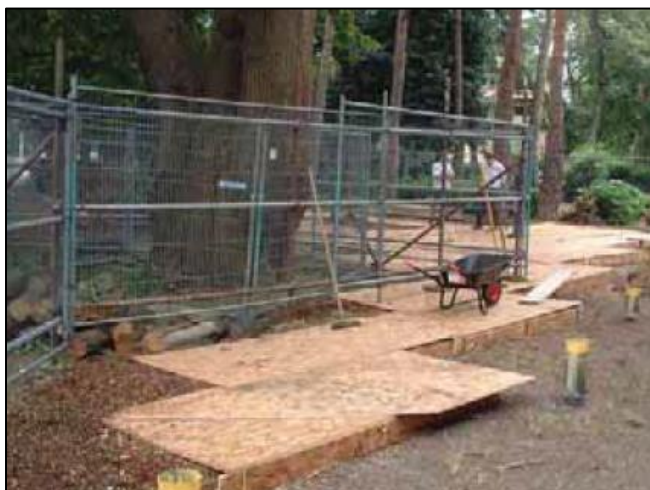
**Figure 2.05 – Example of ground spreader boards atop of a compressible layer of woodchip for use on this Site.**

The ground protection will comprise of 1.2m wide spreader boards atop of a compressible layer of woodchip to 100mm depth.

Ground spreader boards (Figure 2.05) must be sufficient in thickness and durability to withstand scaffold towering and operatives and pinned down into position.

Where outward angled legs are required to support the scaffolding, these too must be placed upon sufficiently sized spreaders or spreader boards to prevent creating divots in the area laid to lawn within the RPA. Both the leg and spread boards must be pinned down into position to prevent slippage.

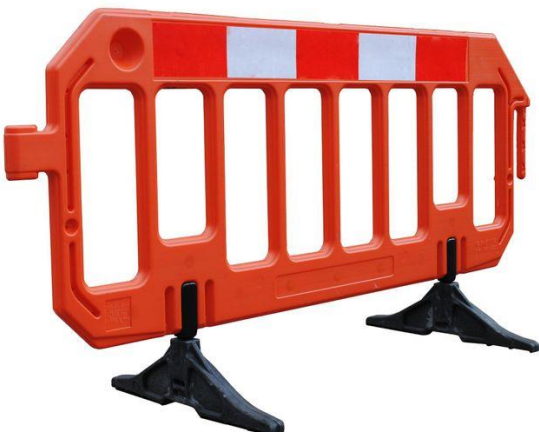
Figure 2.07 – Example of moulded HDPE barrier

In the case of this Site, the installation of standard metal Heras fencing supported by a scaffold framework (as detailed in Figure 2 of BS5837) will be inappropriate for use. Instead, it is proposed that moulded HDPE barrier is used (Figure 2.07), supported with sandbags over the feet.

The tree protection barriers must be installed before any restoration work commences on Site and remain in place until the restoration works have been completed. Collectively, the barriers should form a robust line and not be removed or altered without prior consultation with the Project Arboriculturist and, where necessary, approval from the local planning authority.

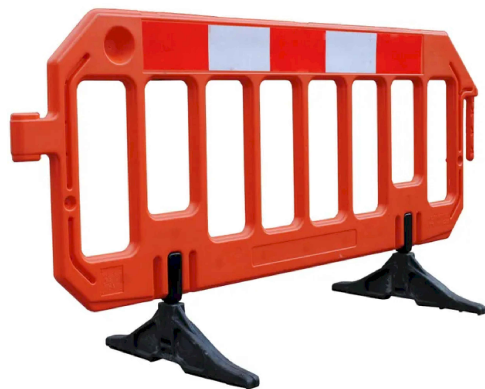
Figure A1.01 - Molded HDPE barrier could act as sufficient protection on this site for these trees but will need to be checked before any works commences.

Barrier (Figure A1.01) to be installed on existing hard surfacing at lawn edge, held down with sandbags.

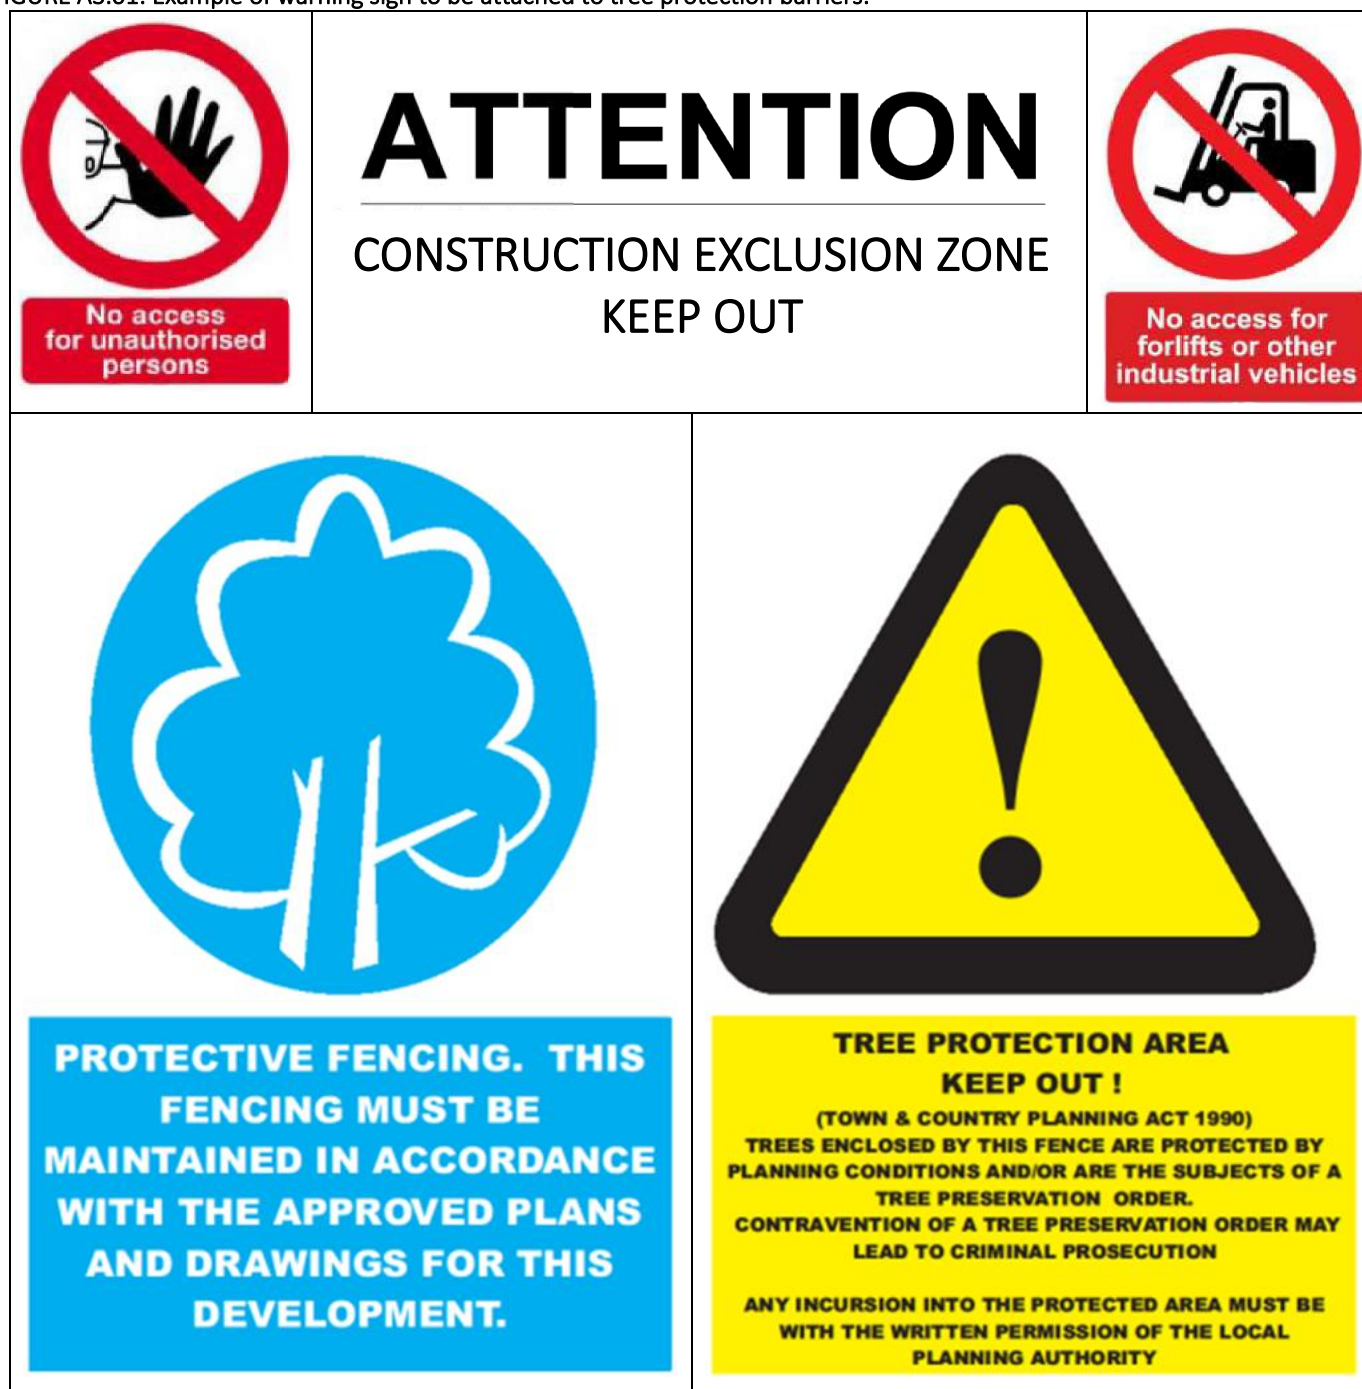
FIGURE A3.01: Example of warning sign to be attached to tree protection barriers.

All-weather notices should be securely attached to the barriers throughout the entire construction phase.

All-weather notices (Appendix 3) should be attached to the barriers with words such as: '*Construction Exclusion Zone - No Access*'. Throughout the construction period, attention should be paid to ensure that barriers remain rigid and complete.
