TAVISTOCK GUILDHALL

INTRUSIVE INVESTIGATION RESULTS,
SECOND FLOOR PLAN

TGH-HYD-XX-02-DR-S-0020

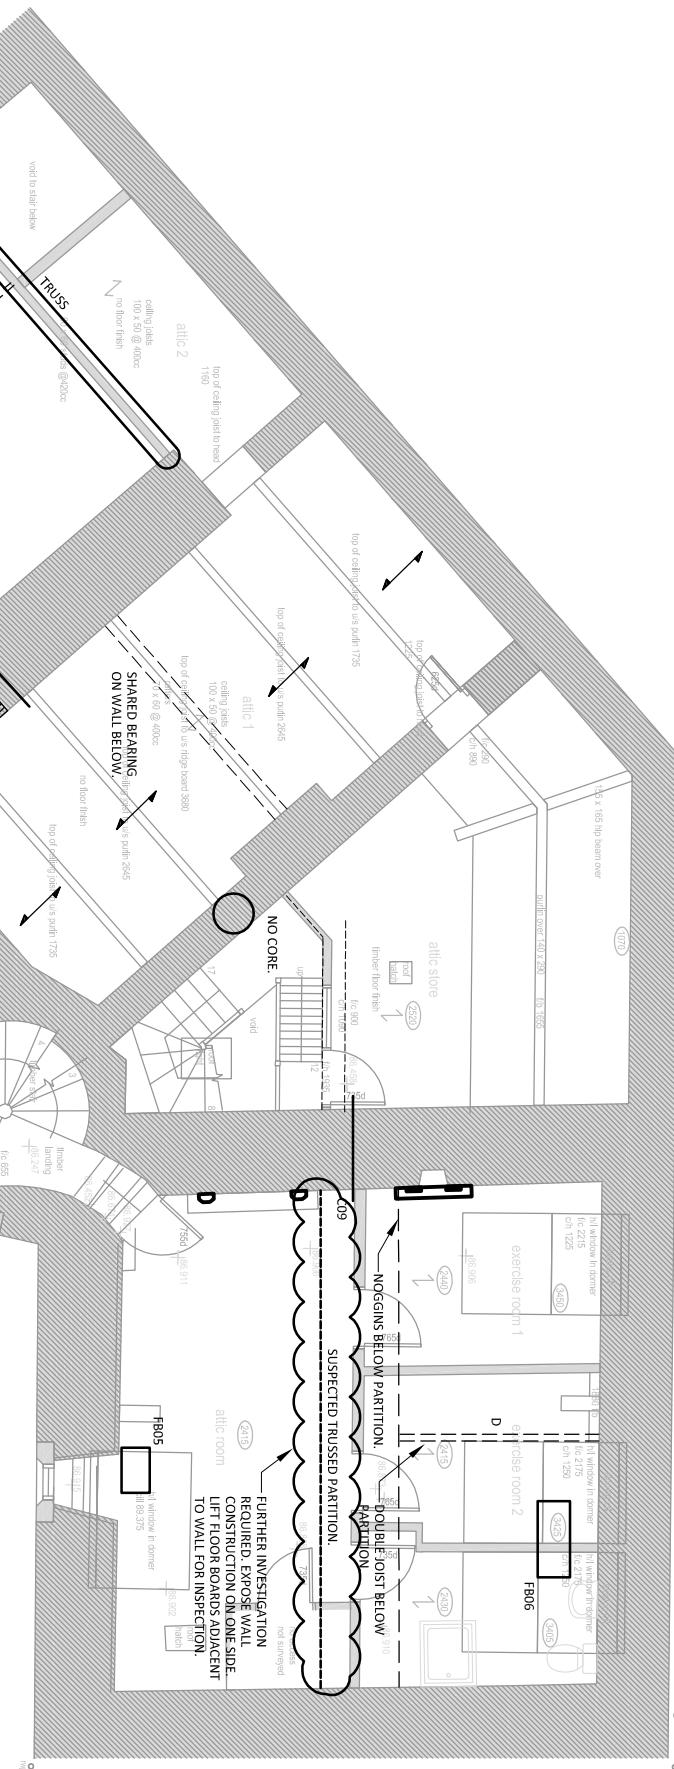
OBSERVATIONS		
C01 SMALL LOOSE DEBRIS ONLY, GENERALLY SOLID	FB01 JOISTS ON SLEEPER WALL, 100x65mm, 300mm C/C, 410mm FFL, - GROUND 22mm BOARDS	B01 JOISTS THROUGH, NO APPARENT LOAD BEARING
C02 GOOD	FB02 JOISTS ON SLEEPER WALL, 100x65mm, @ 410mm, 125x50mm, @ 470mm, 350mm FFL, TO GROUND	B02 JOISTS THROUGH, NO APPARENT LOAD BEARING
C03 GOOD	FB03 SOLID BRICK, 310mm LONG, 40mm FINISHES / 25mm FINISHES	B03 STUD - NON STRUCTURAL
C04 NOT THROUGH, SOME LOOSE BUT ON THE WHOLE, STABLE	FB04 50x150mm + 100 @ 460/480mm	B04 STEEL
C05 SOME LOOSE IN MIDDLE OF WALL	FB05 230x225/220mm 55 @ 400/410mm, SPliced TO 240x745mm, 40 MIN 4 BOLTS	
C06 SOLID	FB05 95x245mm + 45x245mm @ 10mm.	
C07 LOOSE RUBBLE		
C08 MASONRY OKAY, HIT TRUE, MASONRY		
C09 CRACKED, NOT LOOSE, INTERNAL 1200mm LONG		
C10 FRACTURED INTERNALLY 1200mm LONG
