CLIENT
TAVISTOCK GUILDHALL

TITLE
INTRUSIVE INVESTIGATION RESULTS, LOWER GROUND FLOOR PLAN, SHEET 2

DRAWING NO.
TGH-HVD-XX-LG-DR-S-0002

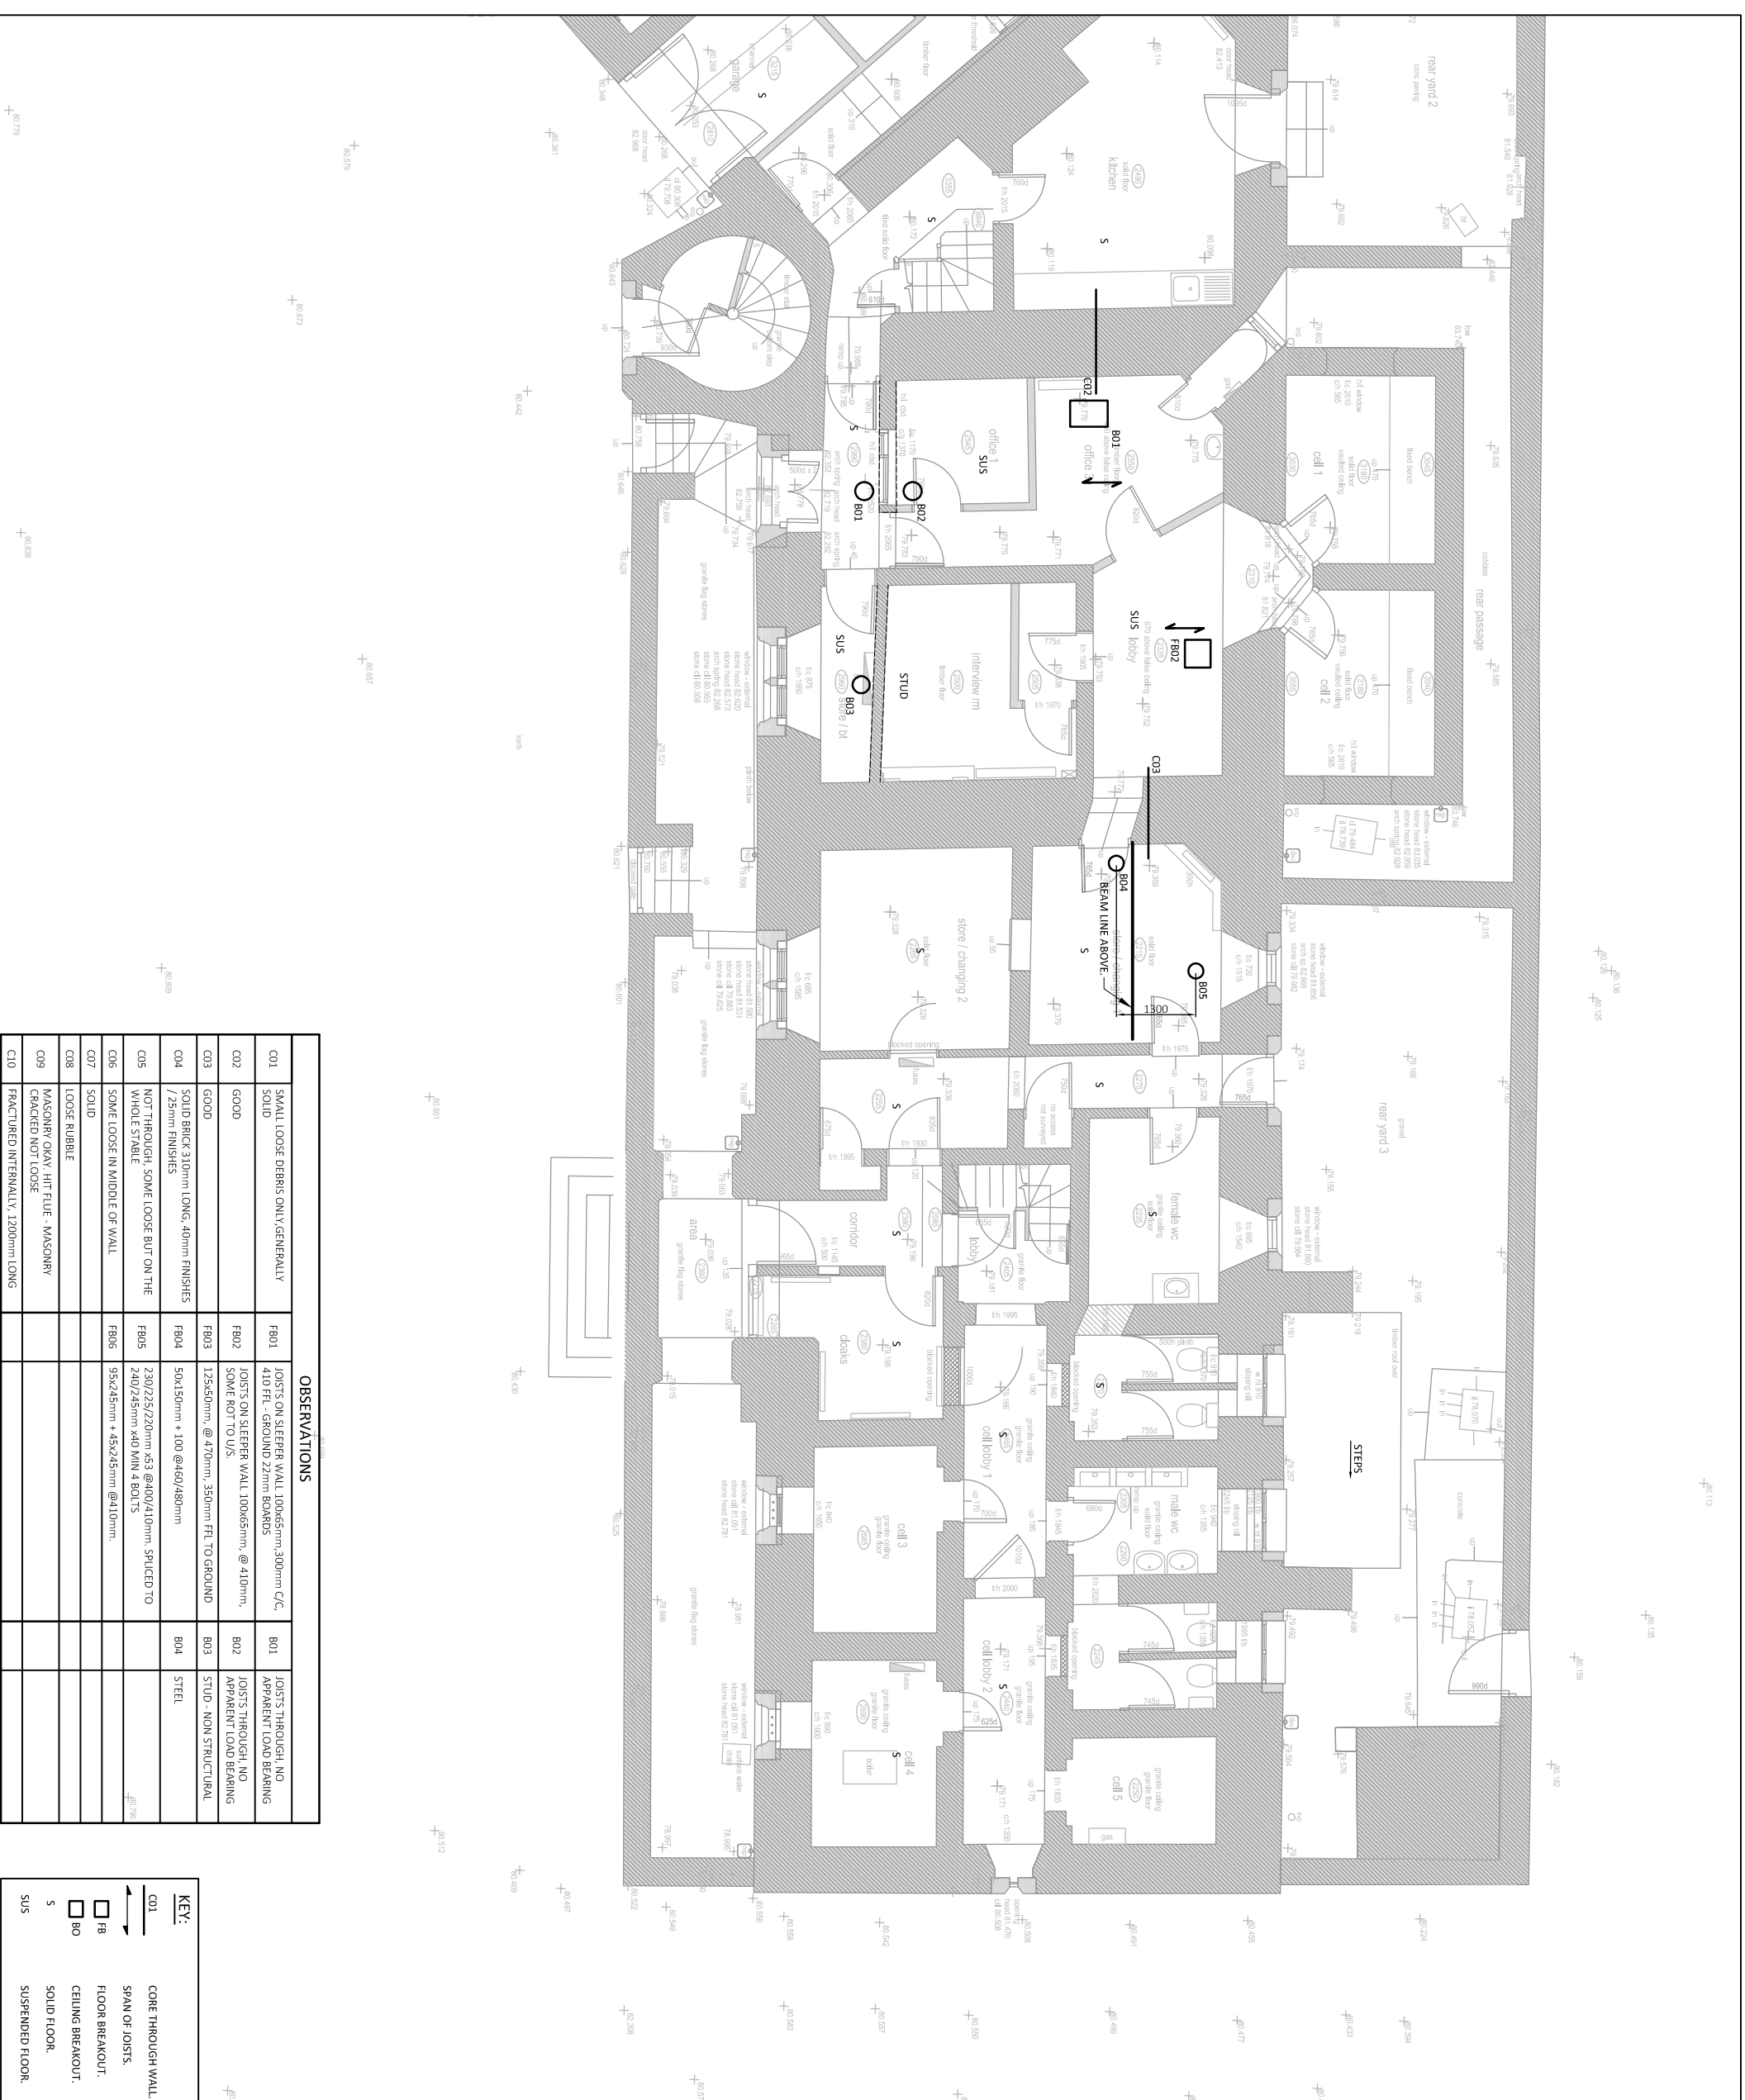
OBSERVATIONS	
C01	SMALL LOOSE DEBRIS ONLY/GENERALLY SOLID
C02	GOOD
C03	GOOD
C04	SOLID BRICK 310mm LONG, 40mm FINISHES / 25mm FINISHES
C05	NOT THROUGH, SOME LOOSE BUT ON THE WHOLE STABLE
C06	SOME LOOSE IN MIDDLE OF WALL
C07	SOLID
C08	LOOSE RUBBLE
C09	MASONRY GYAV HIT FLUE - MASONRY BRICKED NOT LOOSE
C10	FRACTURED INTERNALLY, 1200mm LONG
