## Appendix I

### 1. Previous Archaeological Research

### 2. Description of Survey Area

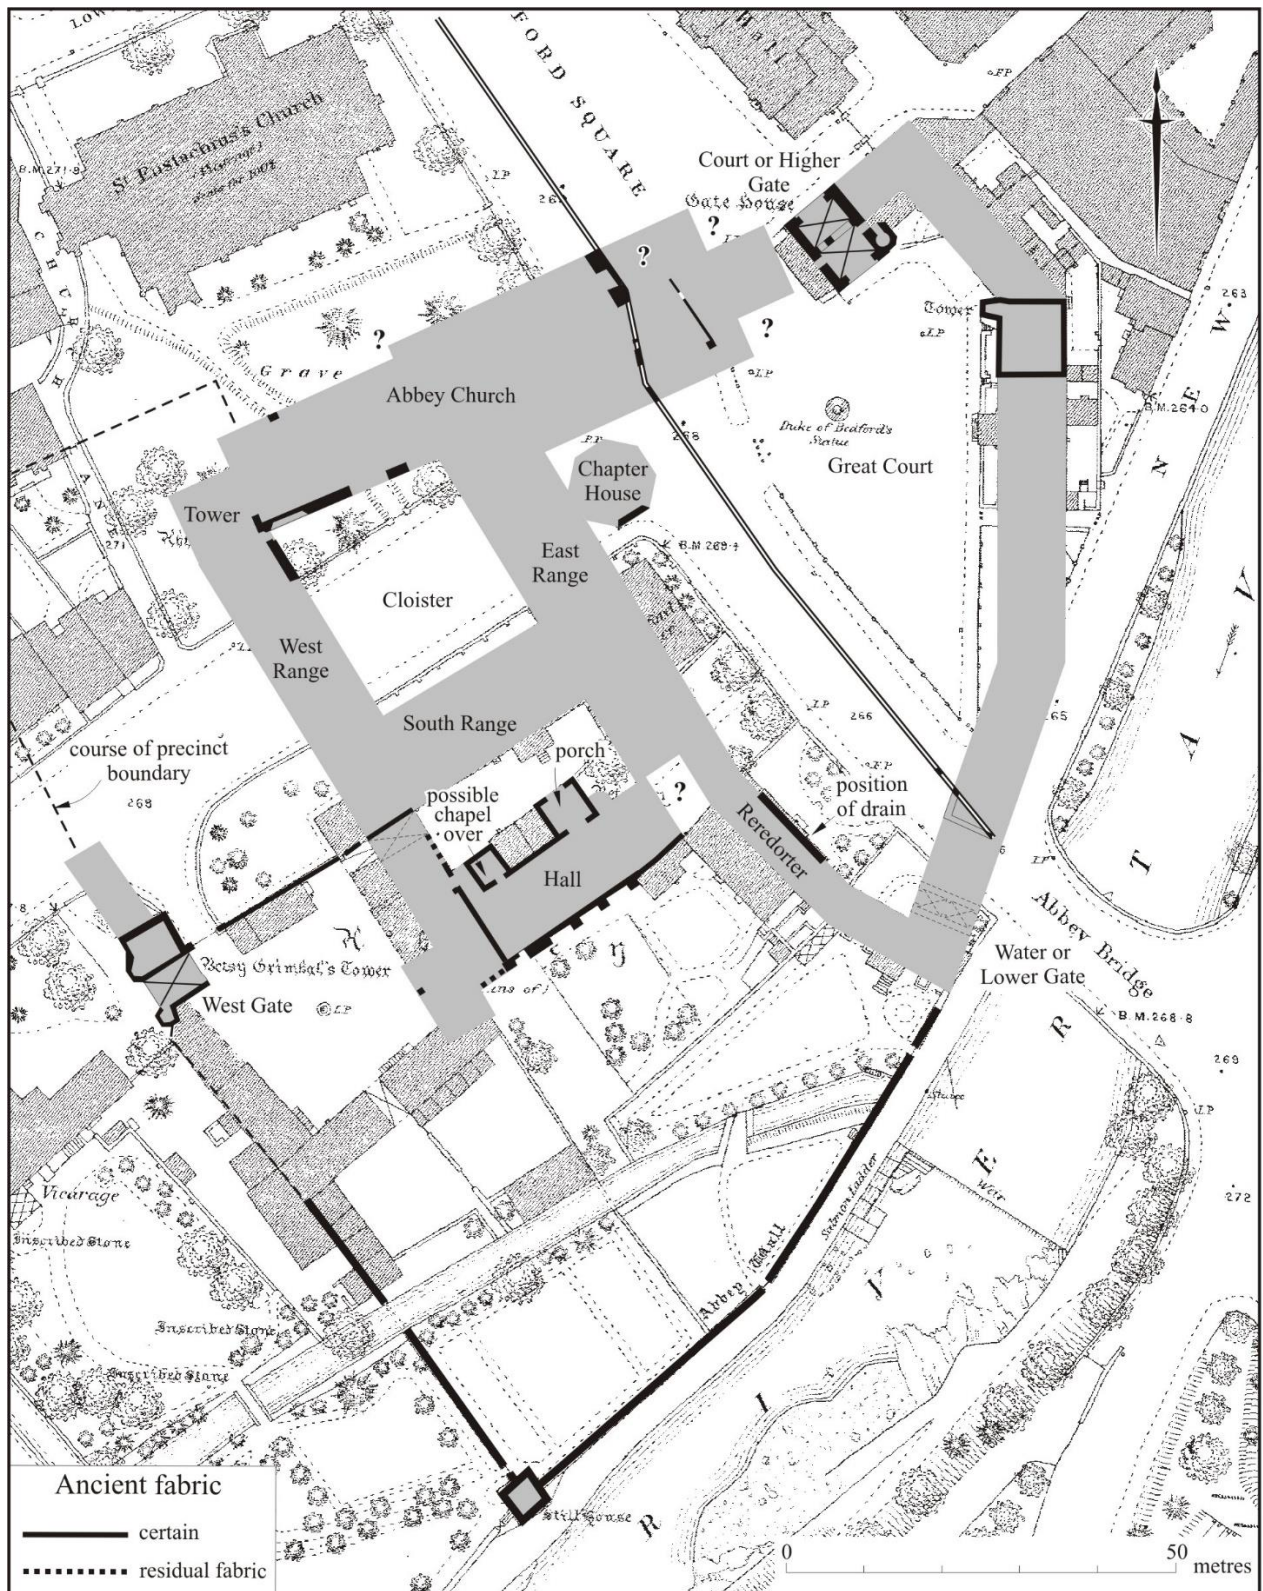
Fig. 4 Conjectural reconstruction of the main elements of the plan of Tavistock Abbey, superimposed on the OS 1:500 town plan of Tavistock, sheet CV.8.17, of 1885 (revised version of Blaylock 1998, fig. 3; and Stead and Blaylock forthcoming, fig. 11).

It is not intended here to provide a full description of the archaeology of the Abbey, but simply to detail the significant research on which the proposed work will build. See fig. 1 for the conjectural reconstruction.
